# A Forensic Investigation: Potential Issues with Recycled Concrete Materials (RCM)

November 18, 2015

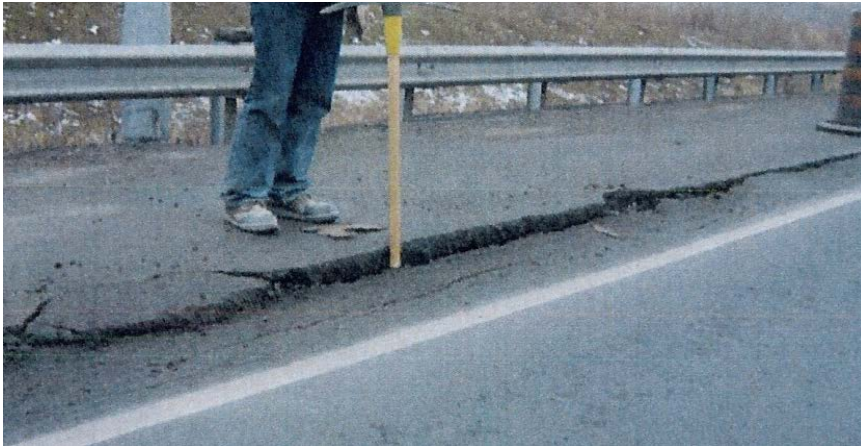
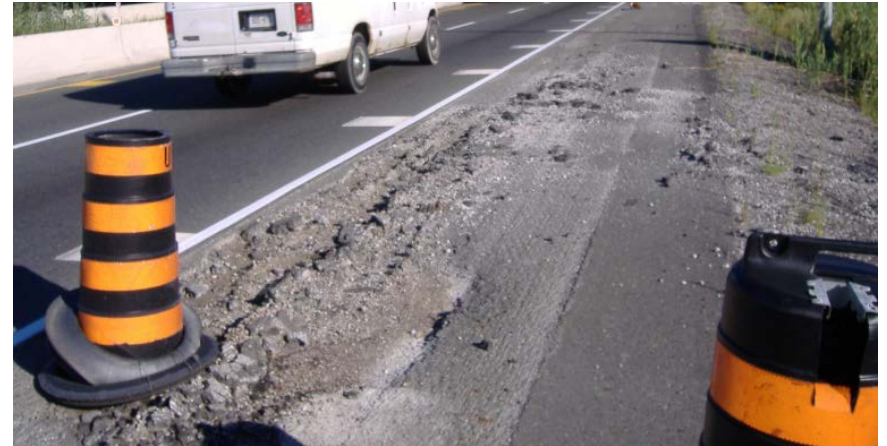
- When deleterious materials sit in water and in contact with cement
  - Material can expand up to 2.5x of its original size
