City of Toronto Crawford Lane LID Pilot

November 16, 2022 MEA Annual Conference: Chelsea Hotel, Toronto

Crawford Lane Pilot

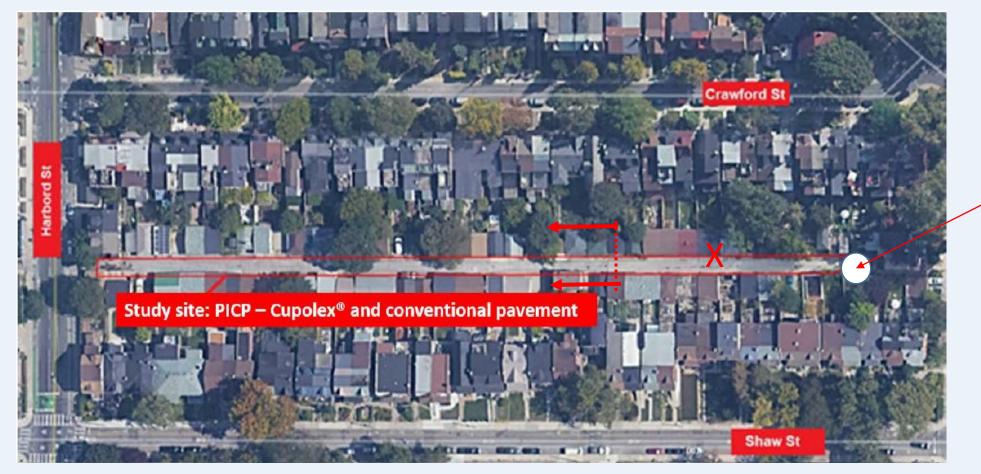
The Pilot: Location and Layout

253 m long **>** 3 sections, each about 84 m long

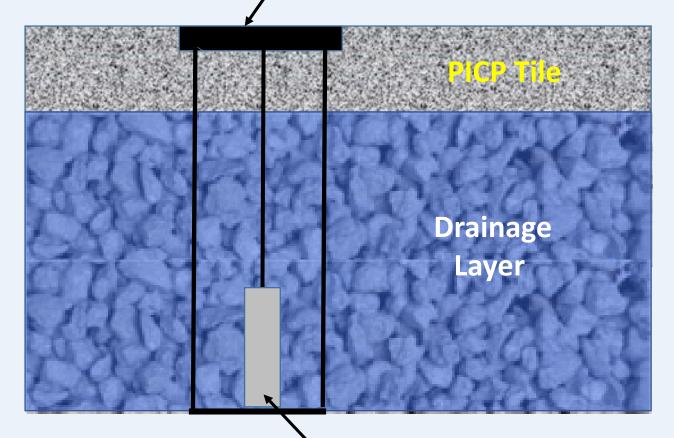
Measuring water infiltration through PICP

/ Small monitoring well

• Water level sensor

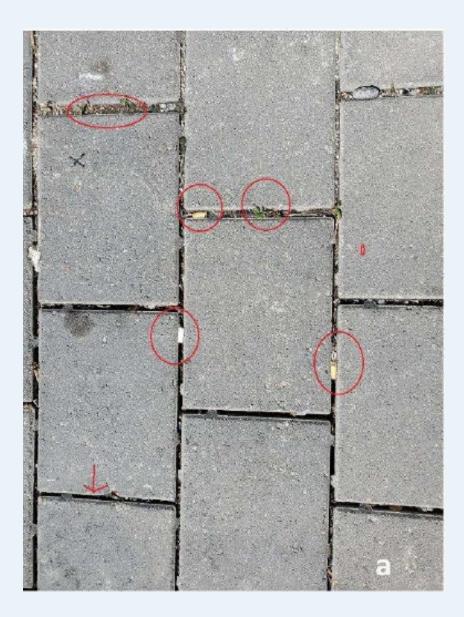
Over the monitoring period, field observations and inspections indicated the deteriorating surface conditions of the PICP.

- The wash-off of the aggregates and
- The accumulation of sediments were observed.

Ontario's CVC LID Manual (2018) recommends **routine maintenance tasks, including surface sweeping, at least once or twice a year.** Sweeping helps in preventing clogging, a major limitation for permeable pavements.
