# Wheatley Gas Well Investigation Update

Ryan Brown, P.Eng.

Director of Public Works, Municipality of Chatham-Kent

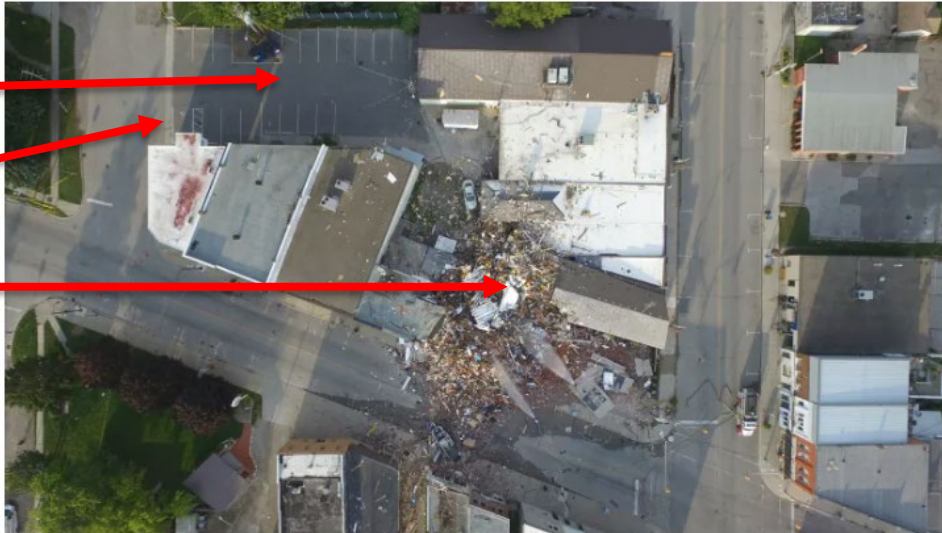
- Through historical information gathering, gas migration testing and ground penetrating radar, 3 Areas of Potential Environmental Concern (APEC) are identified - 2 on municipal property, 1 on private.

APEC 2

APEC 3

APEC 1

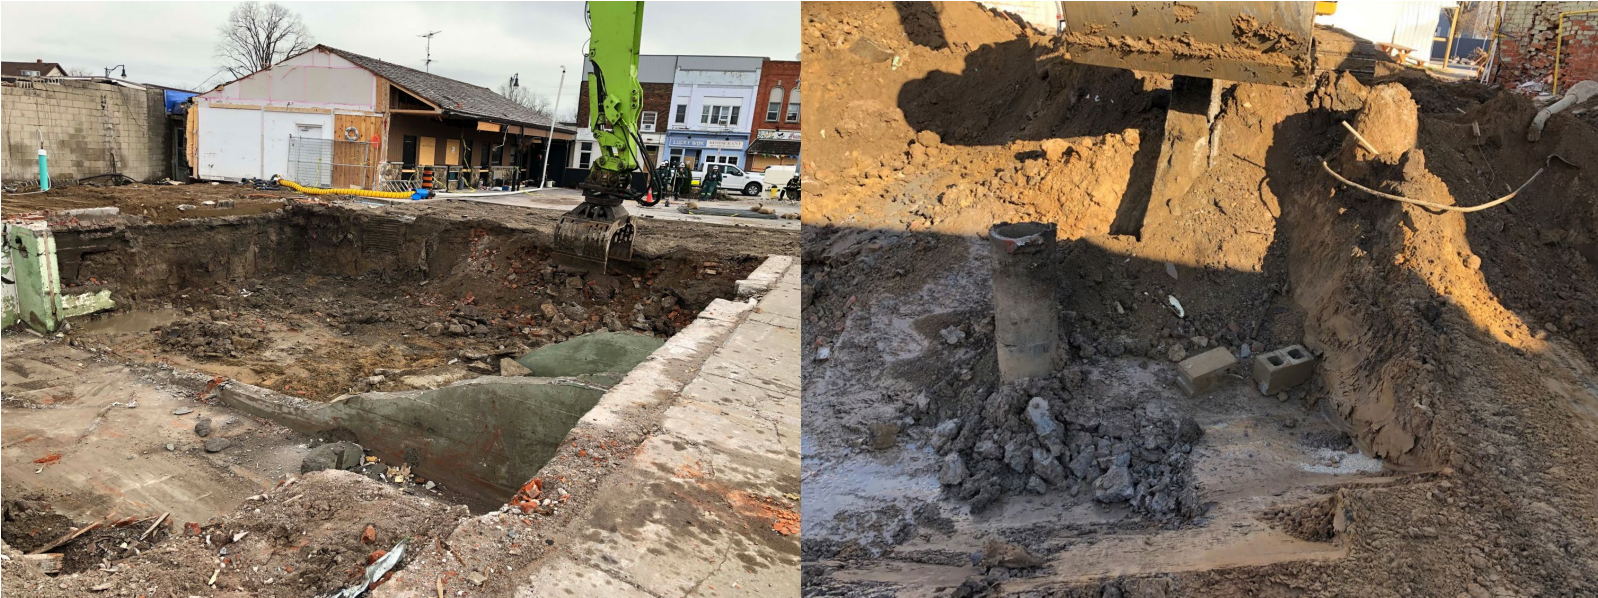
## Apec 1

**Apec 1 is determined to be a ~100' deep, 2" diameter water well at the bottom of a buried casing which the building's floor drain is tapped into.**

- Three wells were found and have been “abandoned” or “re-abandoned” under the Provincial Abandoned Works Program.
- One water well, near the explosion, was found to be the “conduit” of the gas to the surface.
- The gas is “thermogenic” meaning it came from deep underground.
- The gas was in the shallow aquifer, allowing it to get to surface through an old water well.
- How the gas got into the aquifer, and when, is unclear. Further work is being done by Golder to investigate the source of the gas.

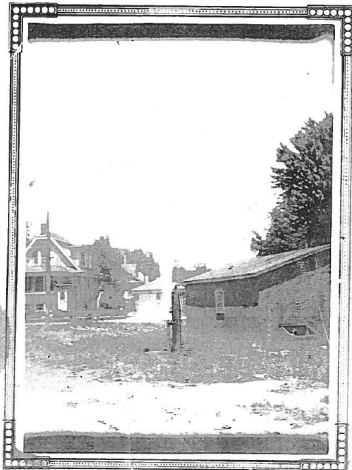
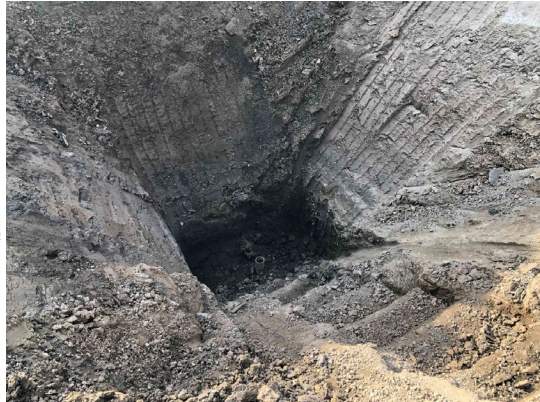
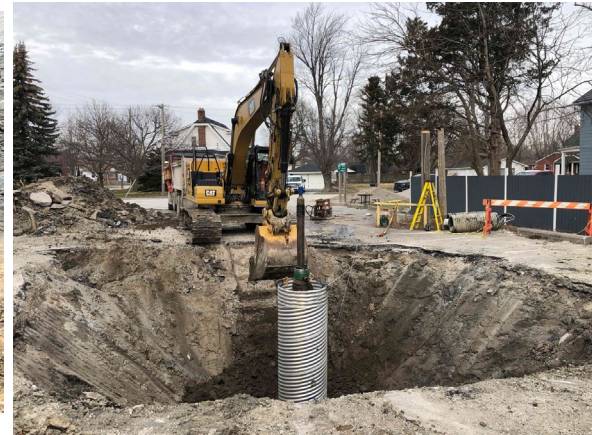
## Apec 2

**Apec 2 gas well is the “Tait Well” documented in MNRF Archives. Abandoned in 1950’s and cut below surface. Drilled in 1890’s to approx. ~1000 feet deep.**

*Geo. Tait A.S. Tait Property*

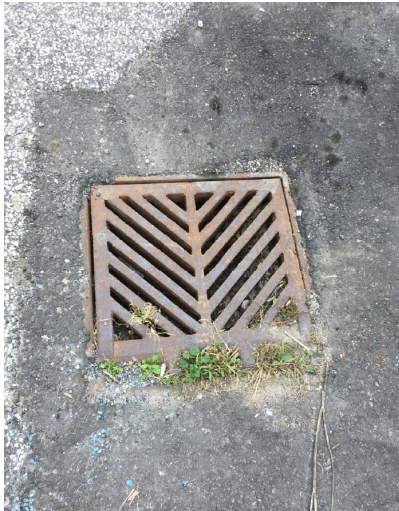
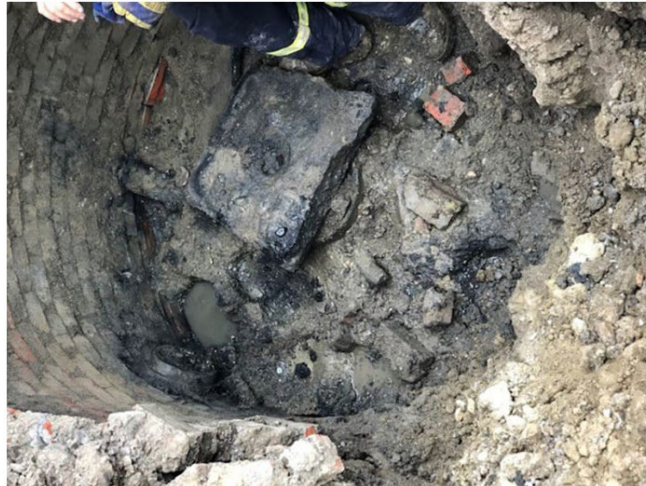
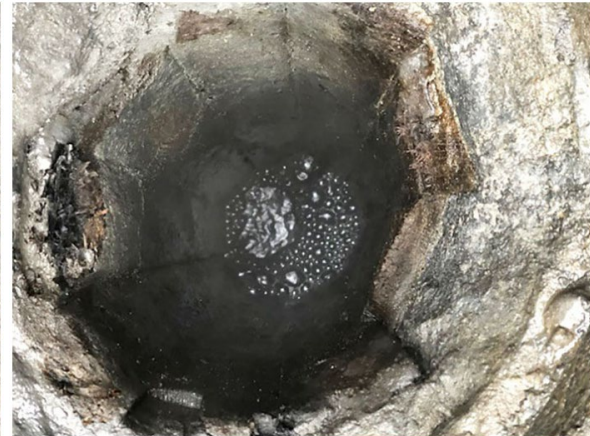
## Apec 3

- Apec 3 is a wooden cased water well at the bottom of a brick well buried beneath a catch basin.**

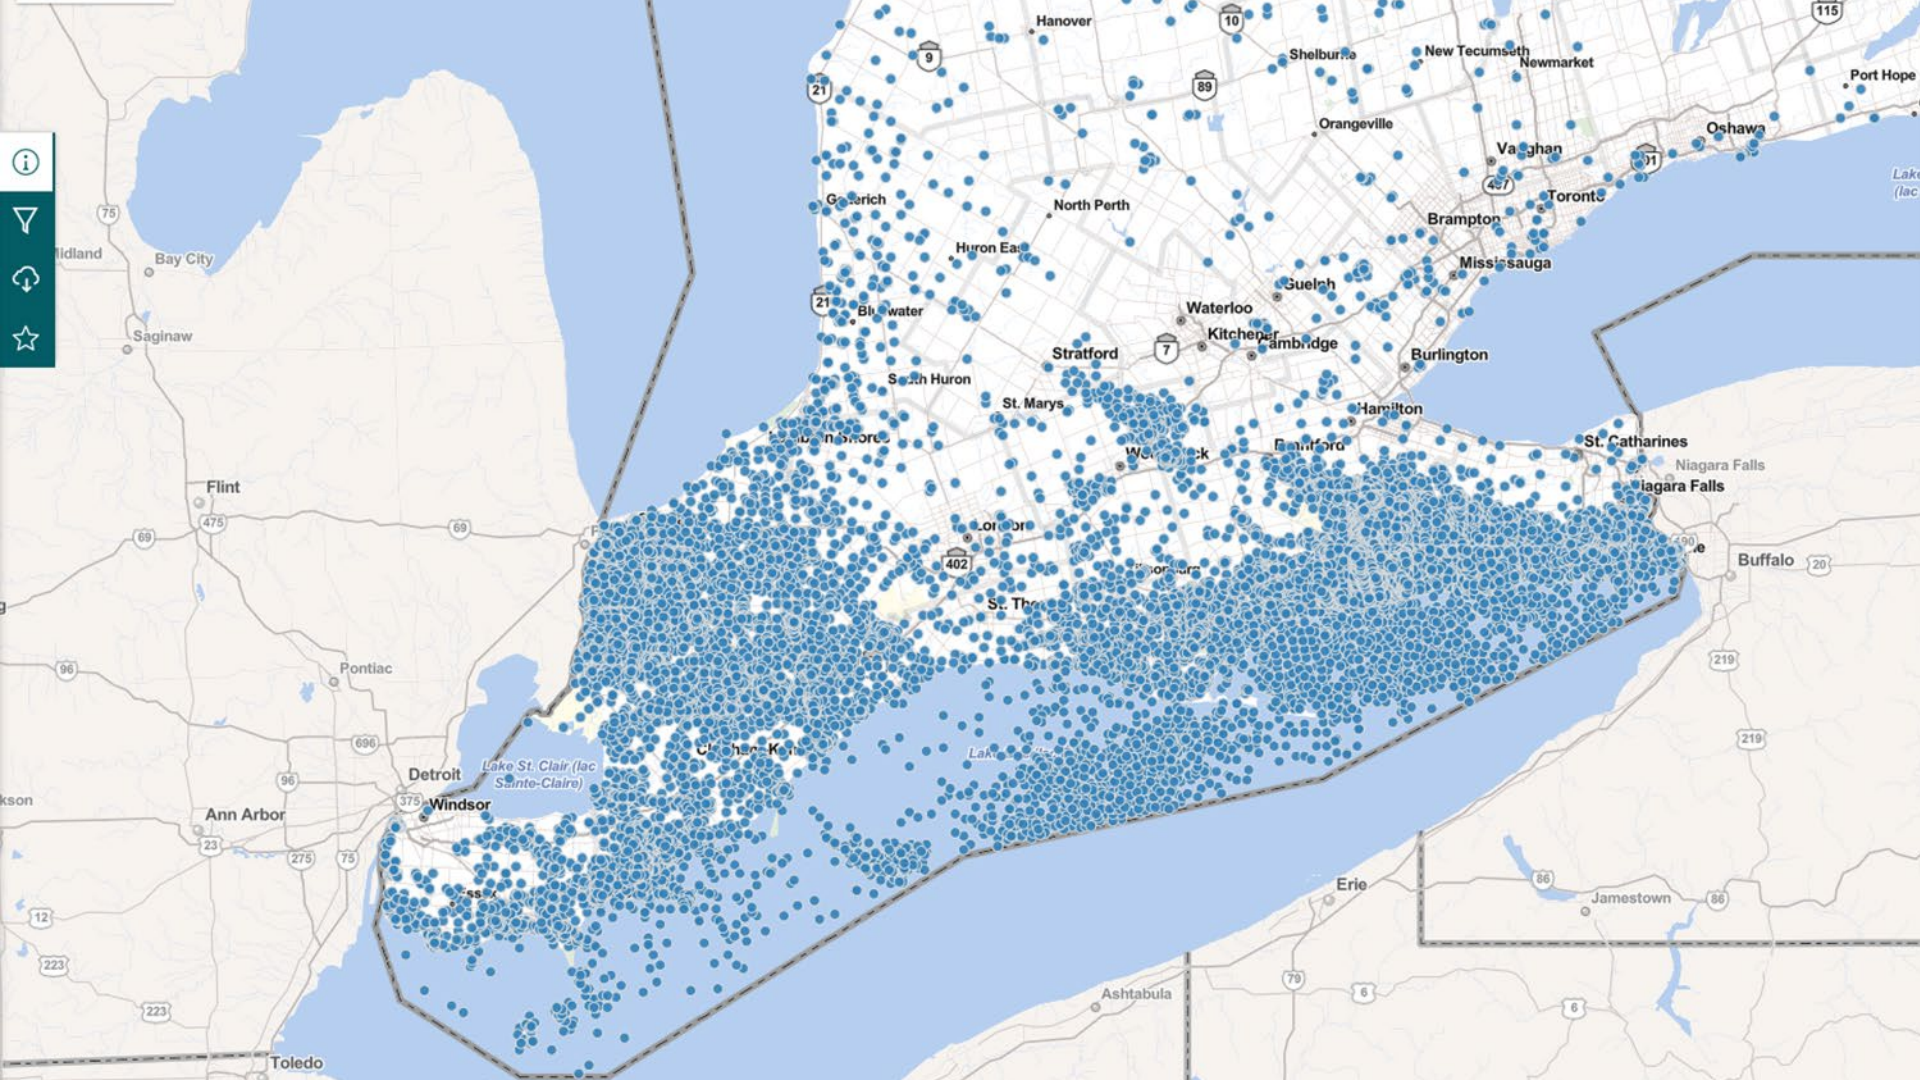
- Most municipalities are going to have to work through legacy oil and gas infrastructure as communities expand.
- Not just a rural municipality issue, each dot on the following slide represents a known oil and gas well; petroleum exploration in Ontario pre-dates accurate record keeping.
- Water wells (which can also emit gas) record keeping is even less accurate.

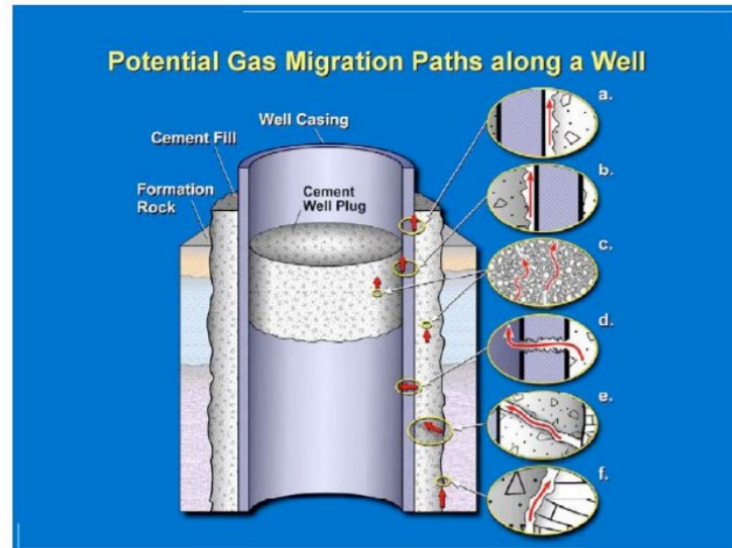
Figure 5 Pathways of Leaks From Gas Wells

- **Plugging of wells is not a perfect science, plugs can fail over time**
