- 1. Project Location
- 2. Project Background & Design
- 3. O.Reg. 406/19: On-Site and Excess Soil Management
- 4. Soil Investigations & Local Contaminants
- 5. Project Impacts & the Watermain Design
- 6. Current Project Status
- 7. Questions

Soil Contamination - Design Impacts and Lessons Learned Project Location

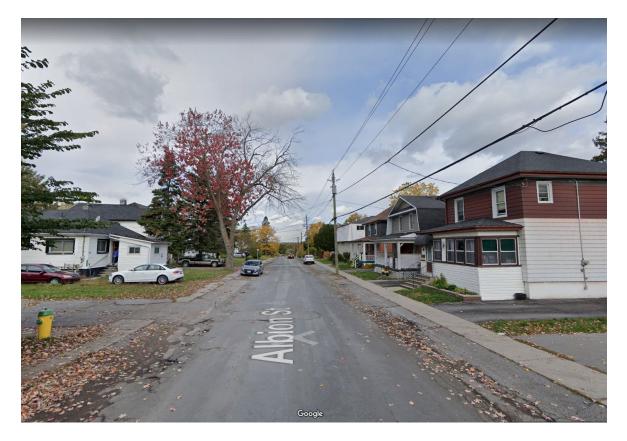
Project Background - Existing Street

Storm water is managed via overland flow through paved shoulders, channeling water to the north Asphalt and paved shoulders are in poor to very poor condition
