New Technology in Practice:

Using Distributed Temperature Sensors to Discover Sources of I&I

Farshad Salehzadeh

Winter 2023

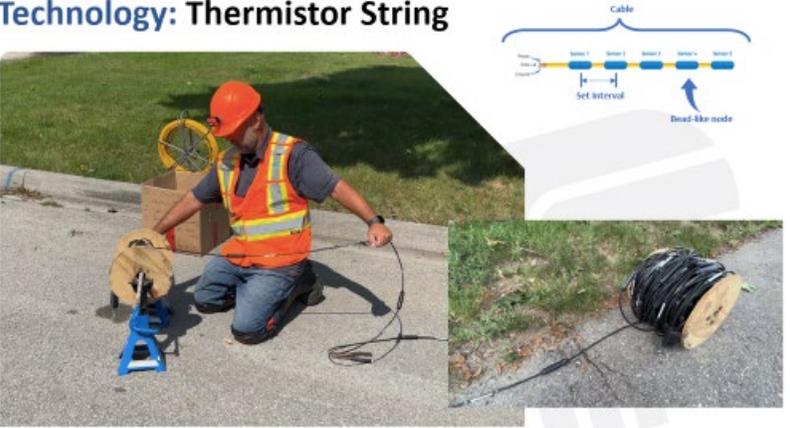
Technology: Thermistor String

Technology: Thermistor String

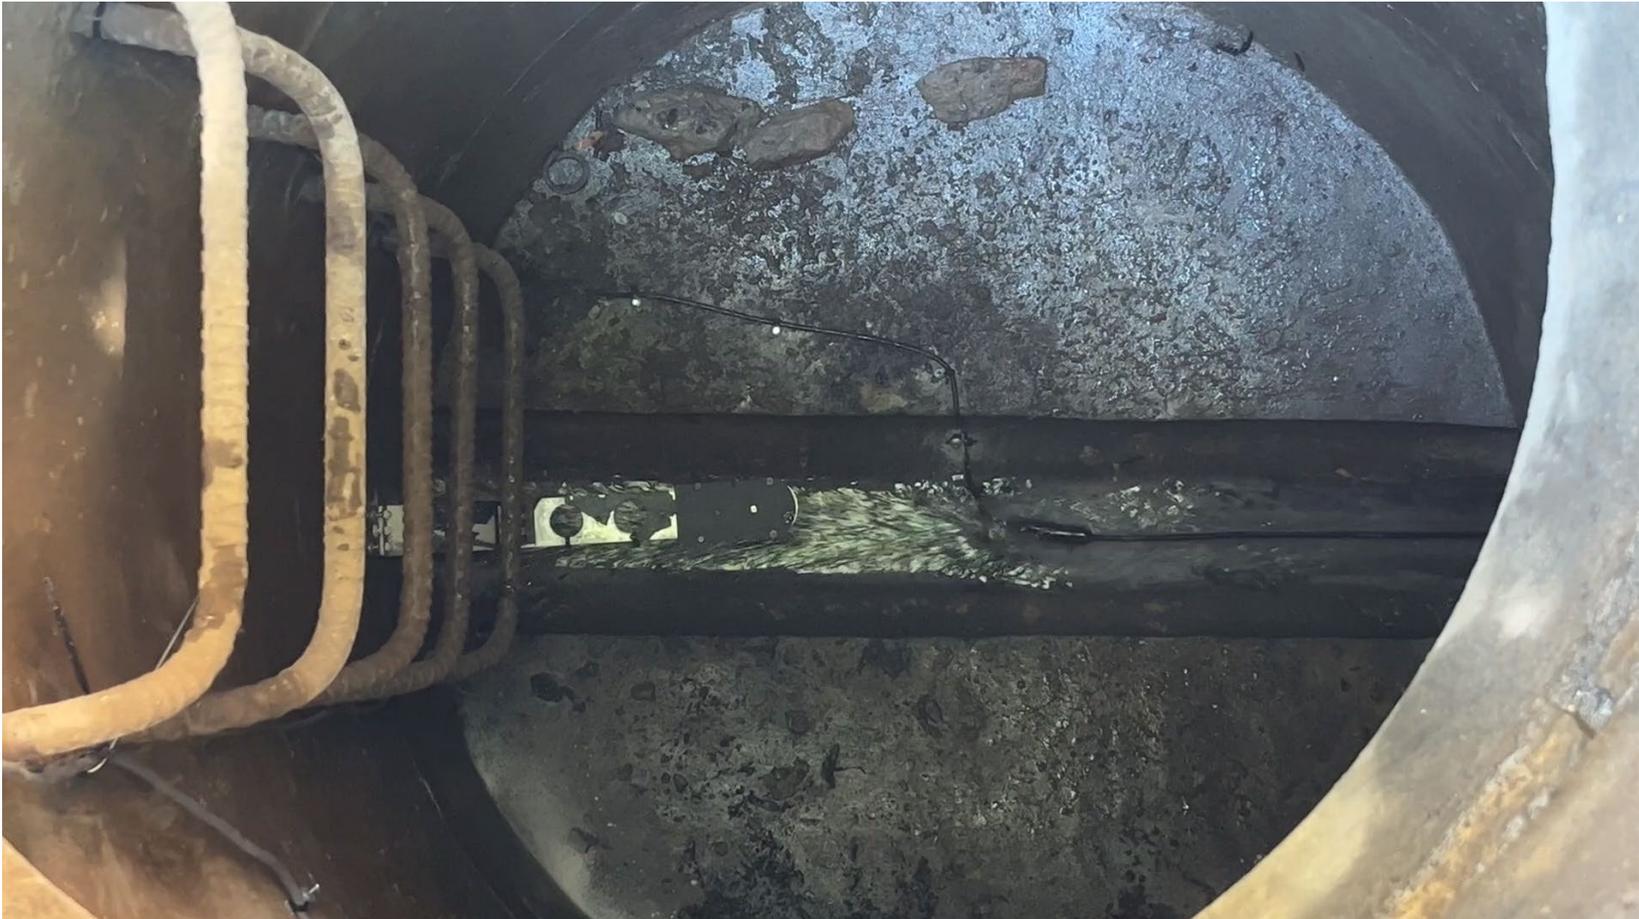
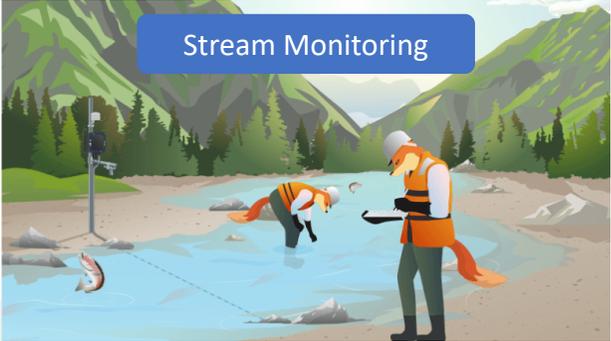
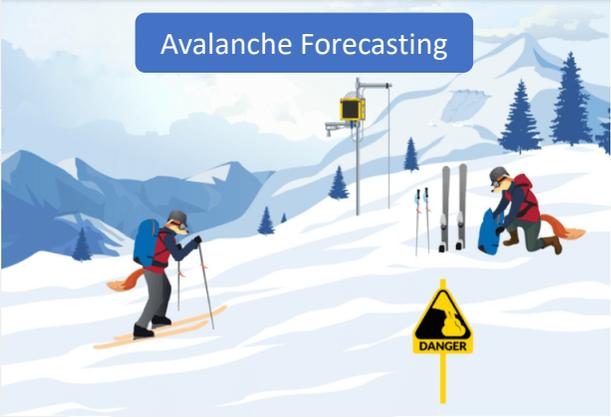
Applications

Sewage Temperature Monitoring

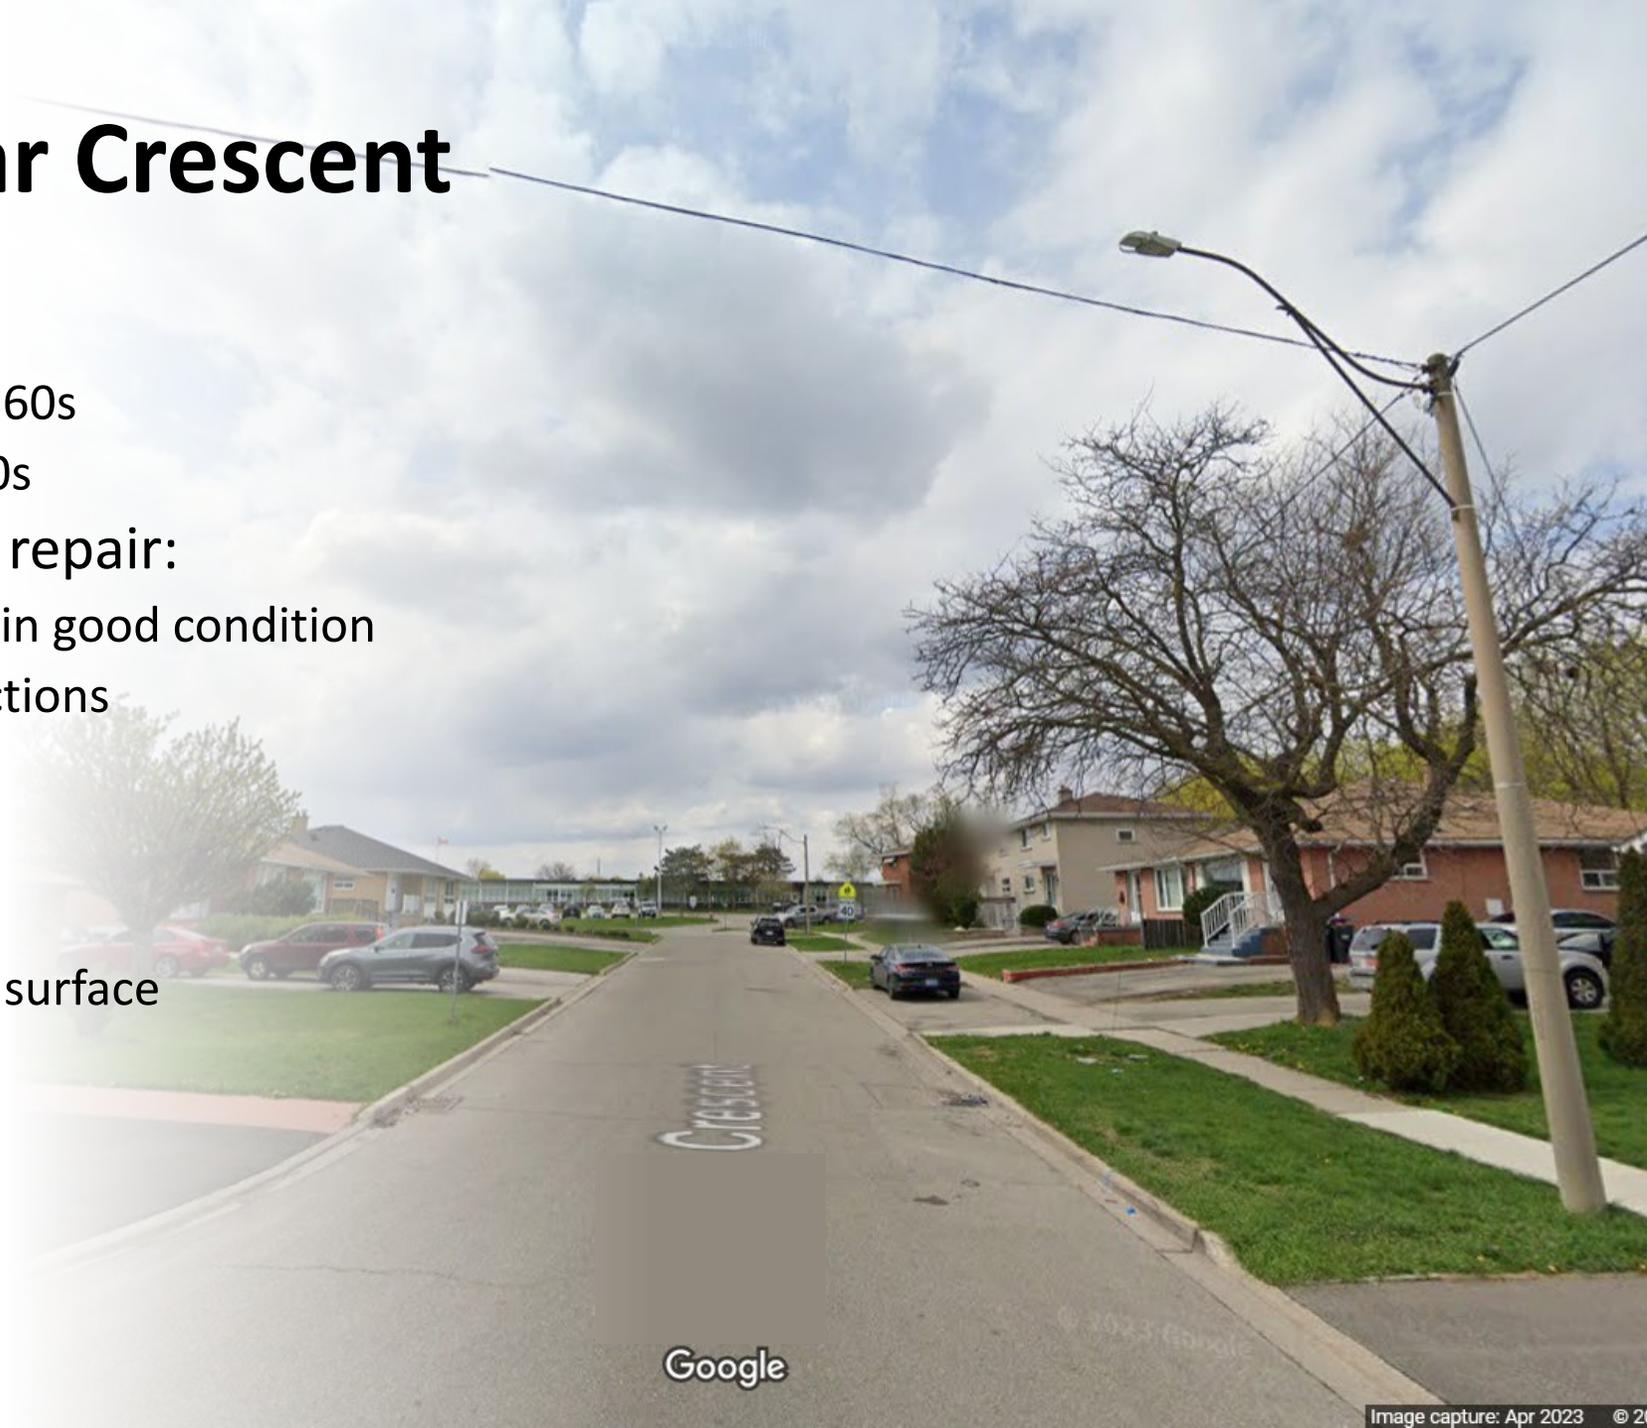
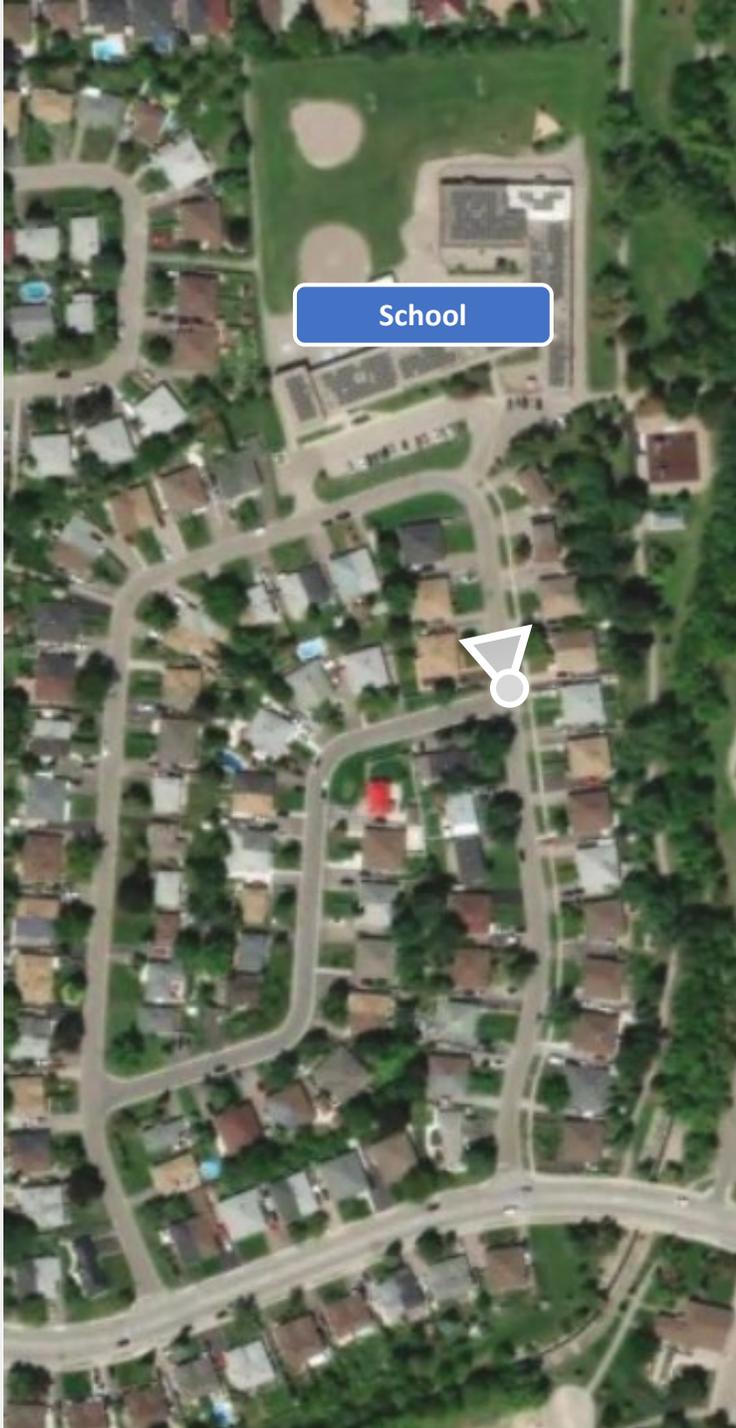
Case Study – Star Crescent

- Separated system:
 - Sanitary system built in 1960s
 - Storm system built in 1970s
- System is in state of good repair:
 - Sewers and manholes are in good condition
 - There are no cross-connections
- Completed inspection:
 - Smoke testing
 - Multiple rounds of CCTV
 - All downspouts are to the surface

Case Study – Star Crescent

- Separated system:
 - Sanitary system built in 1960s
 - Storm system built in 1970s
- System is in state of good repair:
 - Sewers and manholes are in good condition
 - There are no cross-connections
- Completed inspection:
 - Smoke testing
 - Multiple rounds of CCTV
 - All downspouts are to the surface

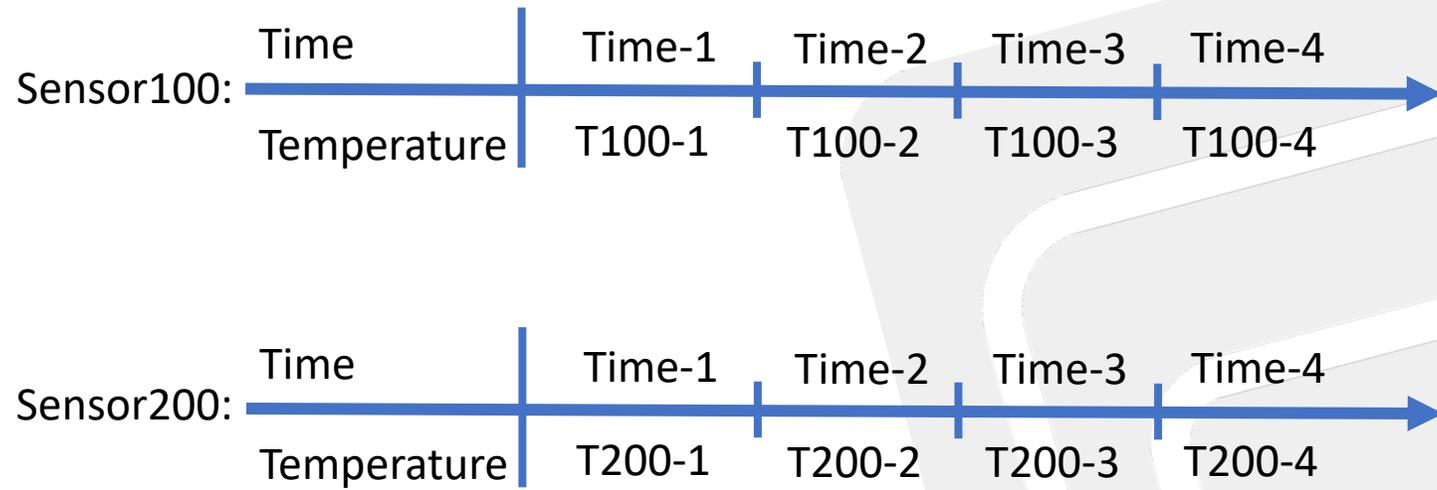
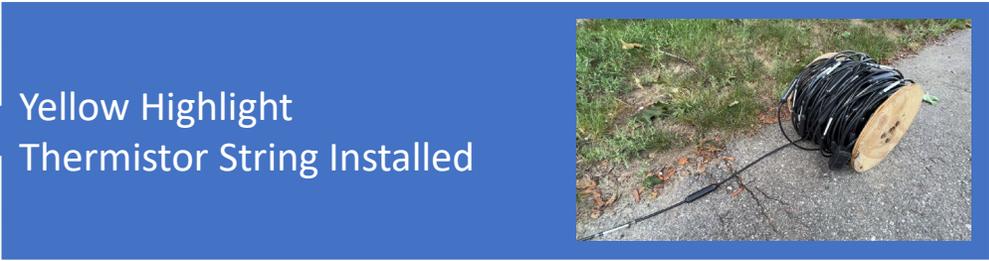
Each sensor records the temperature on regular interval:

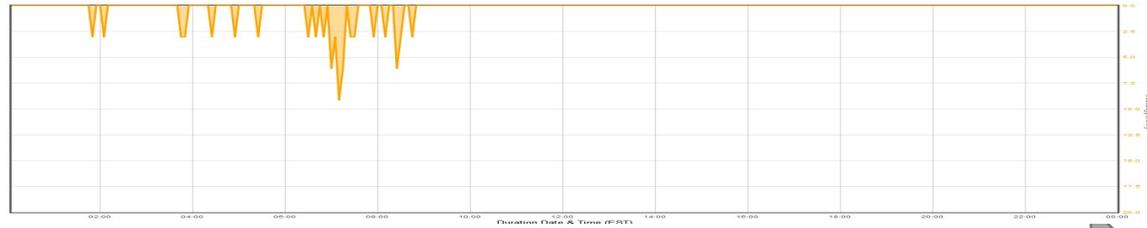
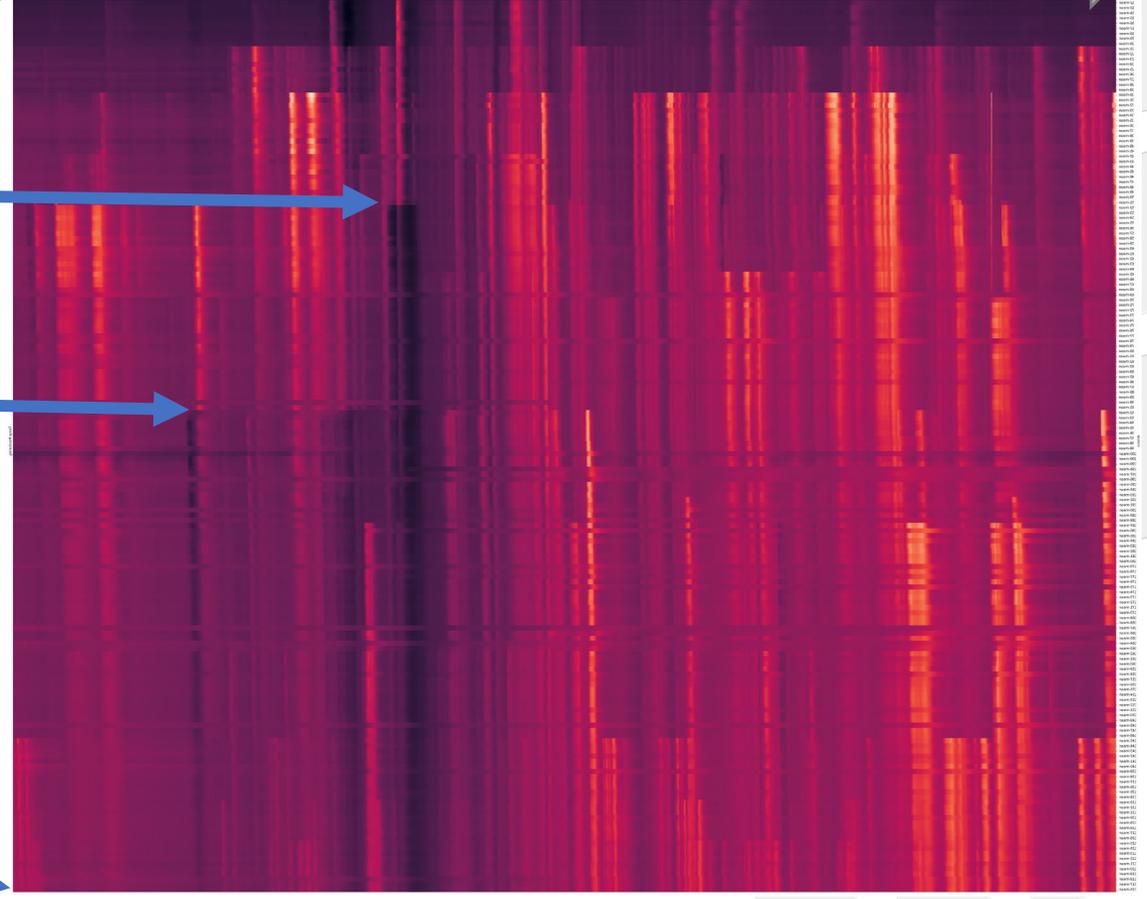
October 21, 2020

Time

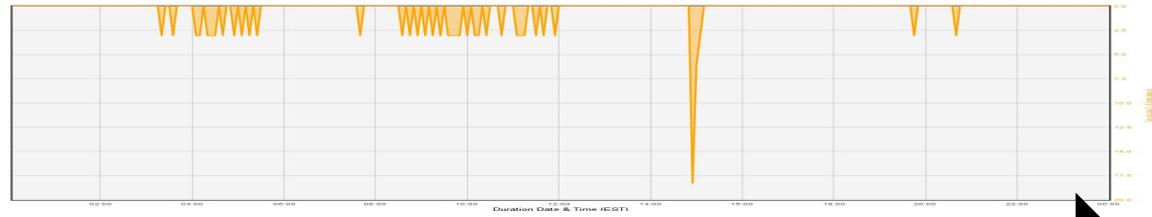
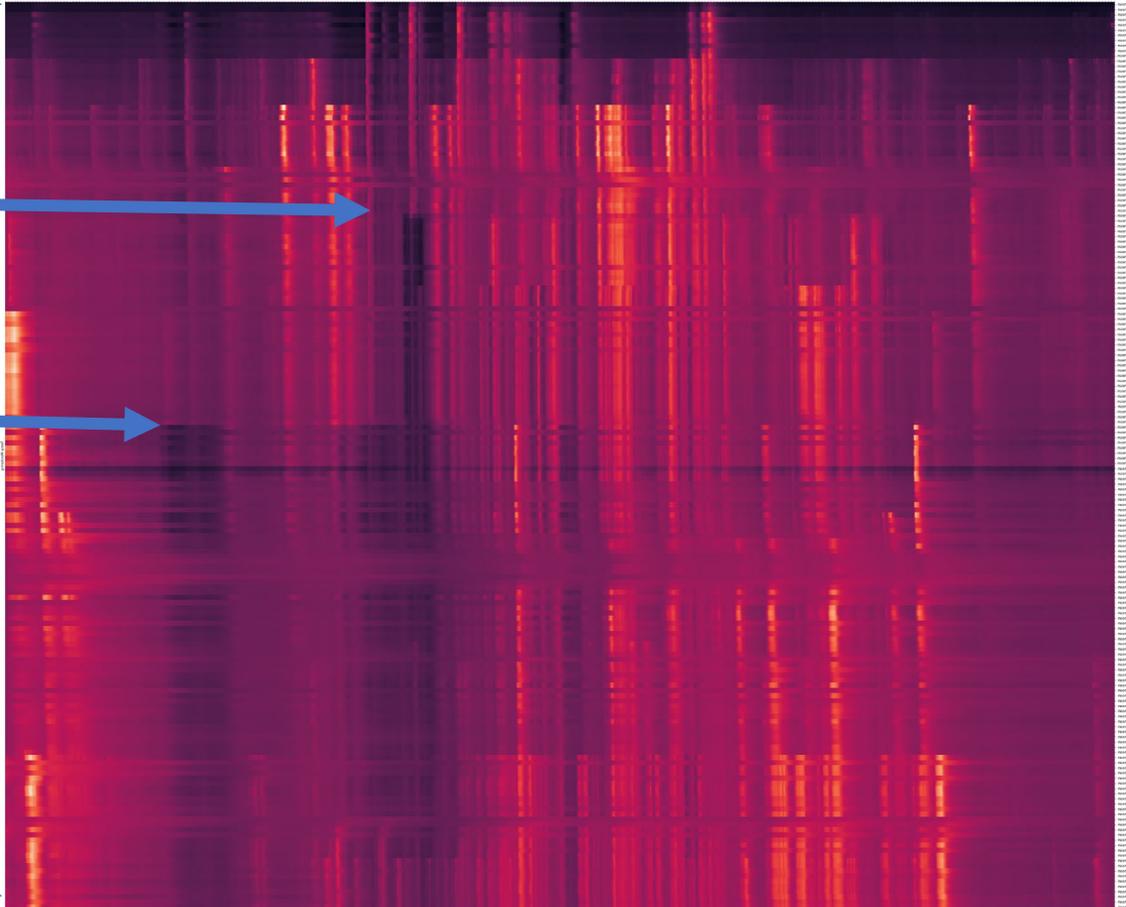
November 15, 2020

Time

Follow up with Wet-CCTV

- 9 Attempts
- Confirmed active laterals during storm event
