Long Point Causeway Bridge Replacement

2023 MEA Conference & AGM - Sarnia/Lambton

November 17, 2023
Bradley Dufour

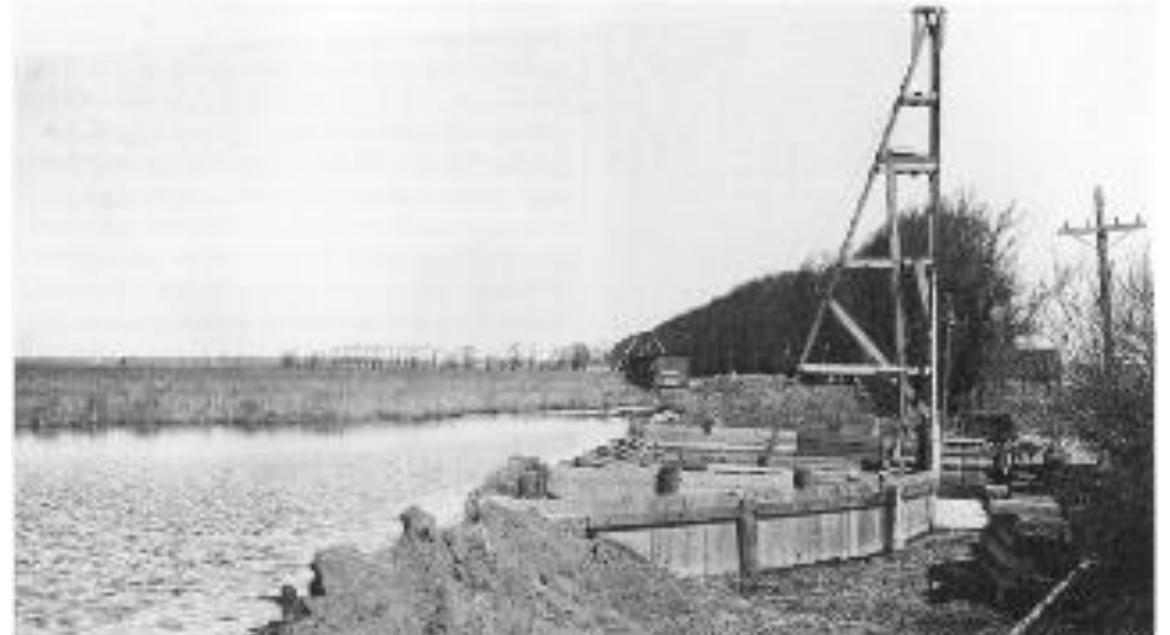
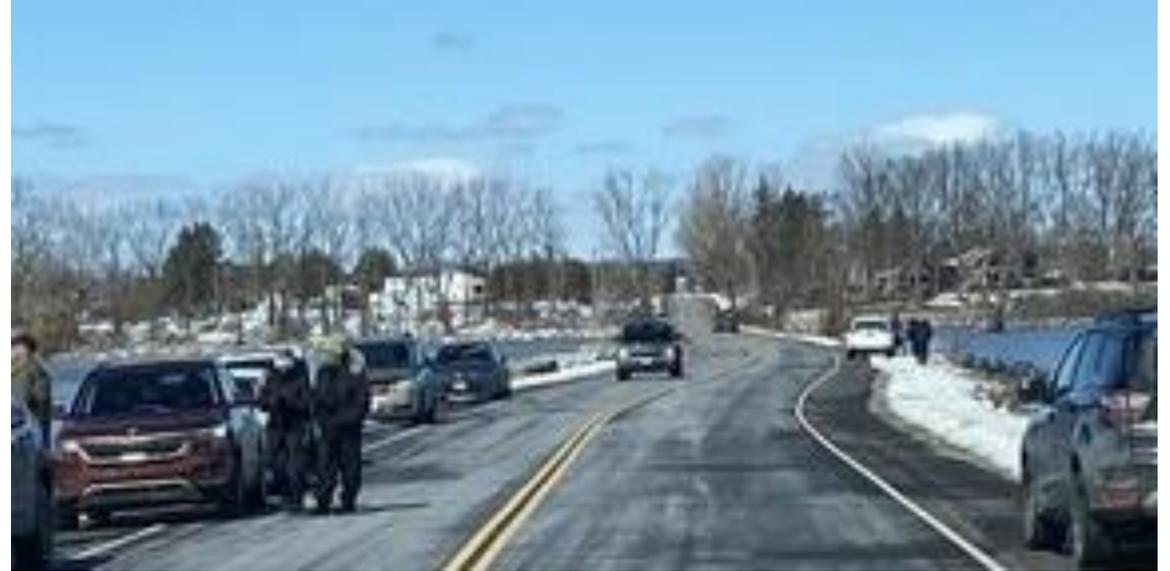
Existing Road

- Long Point Causeway was constructed in 1957.
- 2-lane north-south arterial road.
- Ontario's South Coast Scenic Route.
- Poor pavement and substandard safety and operational conditions.
- Attractive for tourists.

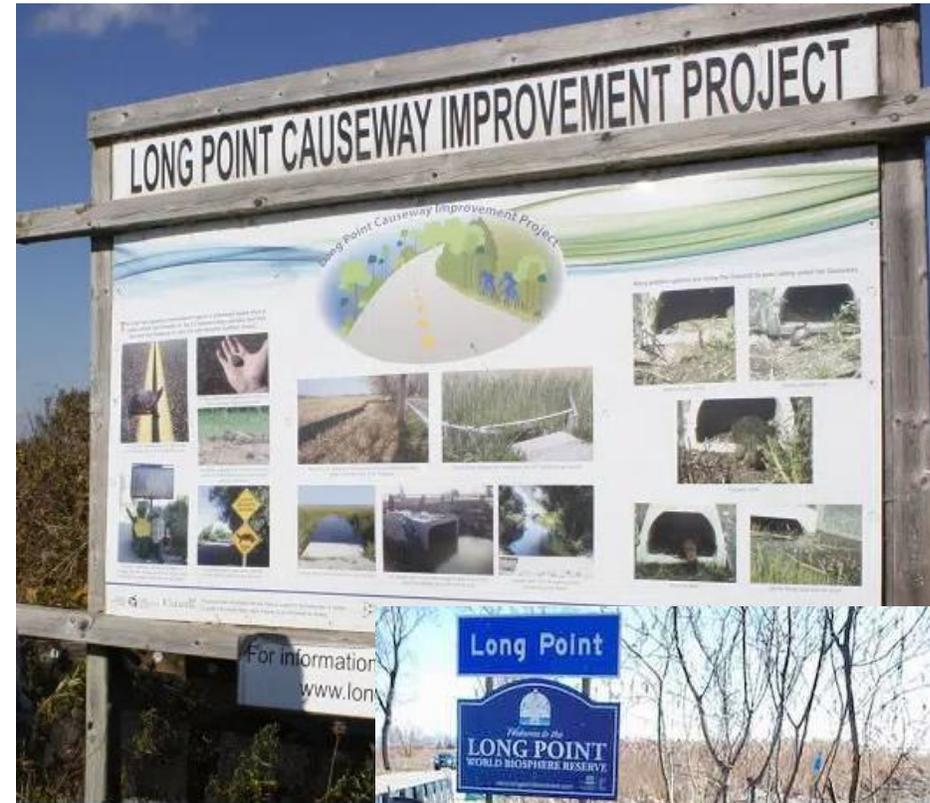
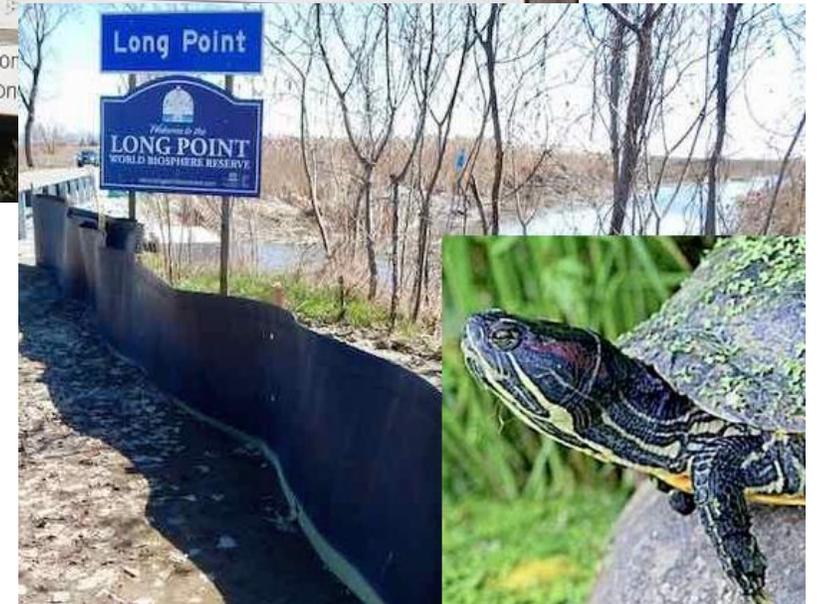
Existing Road Cont.

- Physical barrier.
- Basking and nesting reptiles.
- Known hotspot for wildlife mortality.
- Long Point Causeway Improvement Project:
 - Open grate ACO tunnels, concrete box culverts and the bridge promote wildlife passage.
 - Measures in place to reduce mortalities:
 - Static signage
 - Digital signage
 - Exclusionary fencing

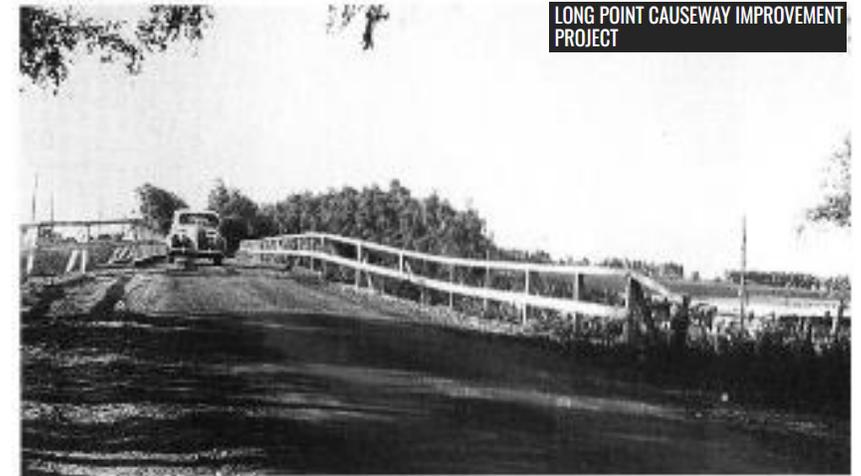
- Originally constructed in 1959.
- Eligible for designated under the *Ontario Heritage Act* - unique example of a simple timber trestle.
- Total deck length of 32.9 m and an overall width of 11.3 m with two-lane asphalt surface.
- Last rehabilitated in 1997.
- 2016 OSIM - major rehabilitation or replacement within 1-5 years.
- Emergency repairs completed in 2018 in response to extended deflection.

The Causeway was constructed with wooden bridges. The longest bridge spanning Big Creek is shown here.

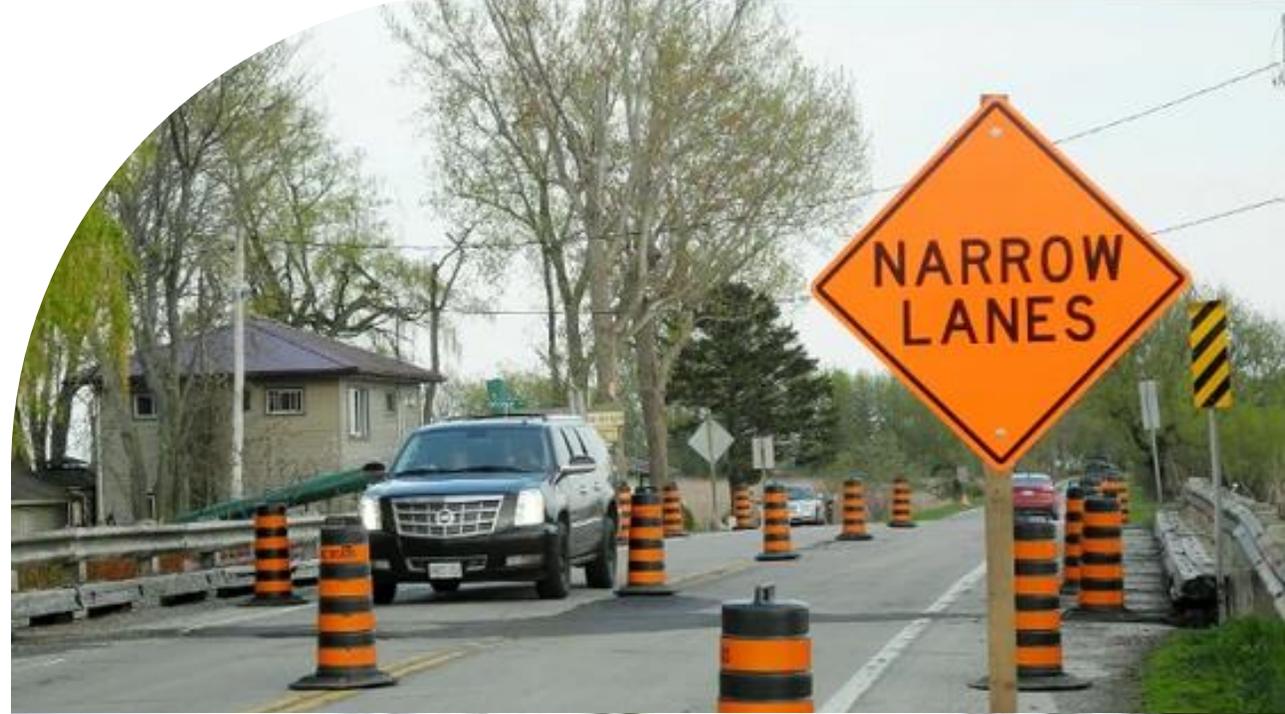
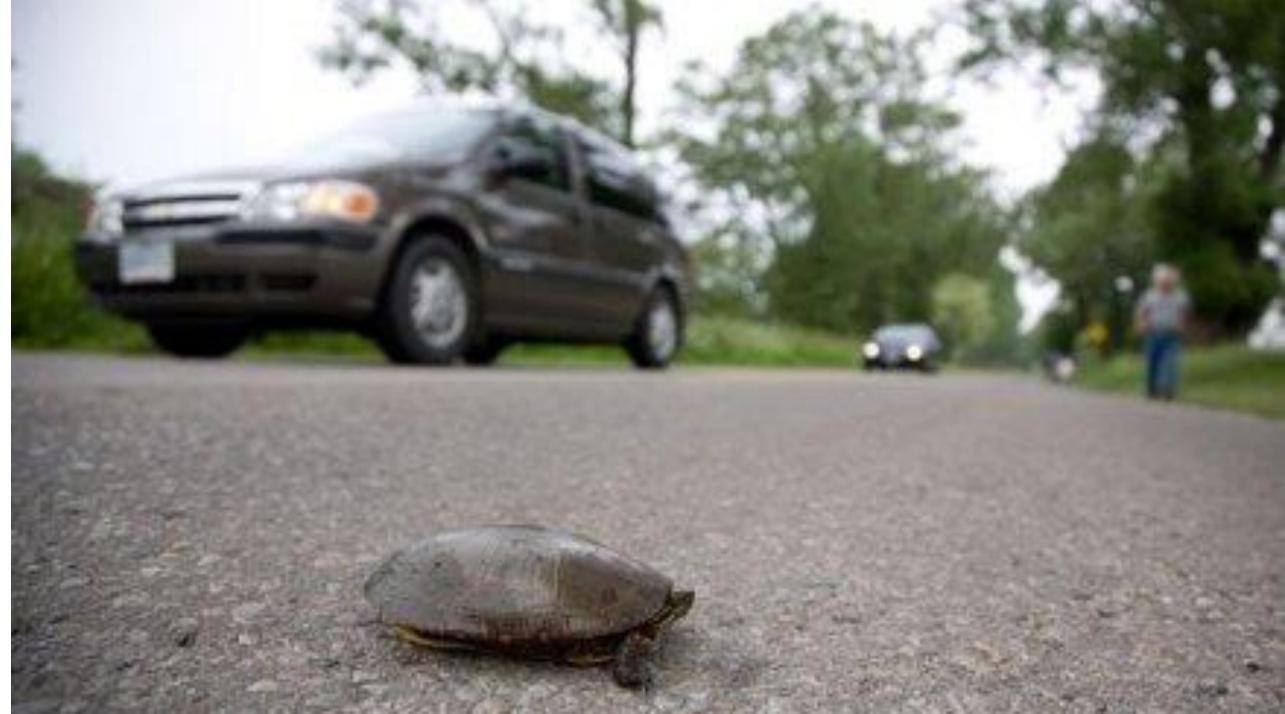
- Schedule B Municipal Class EA completed in 2019.
- 'Long List' and 'Short List' developed for bridge replacement alternatives.
- Preferred Alternative:
 - **Horizontal alignment shift 7 m to the west to accommodate staged construction.**
 - No change in vertical alignment to maintain driveways - maintains existing navigational clearance.

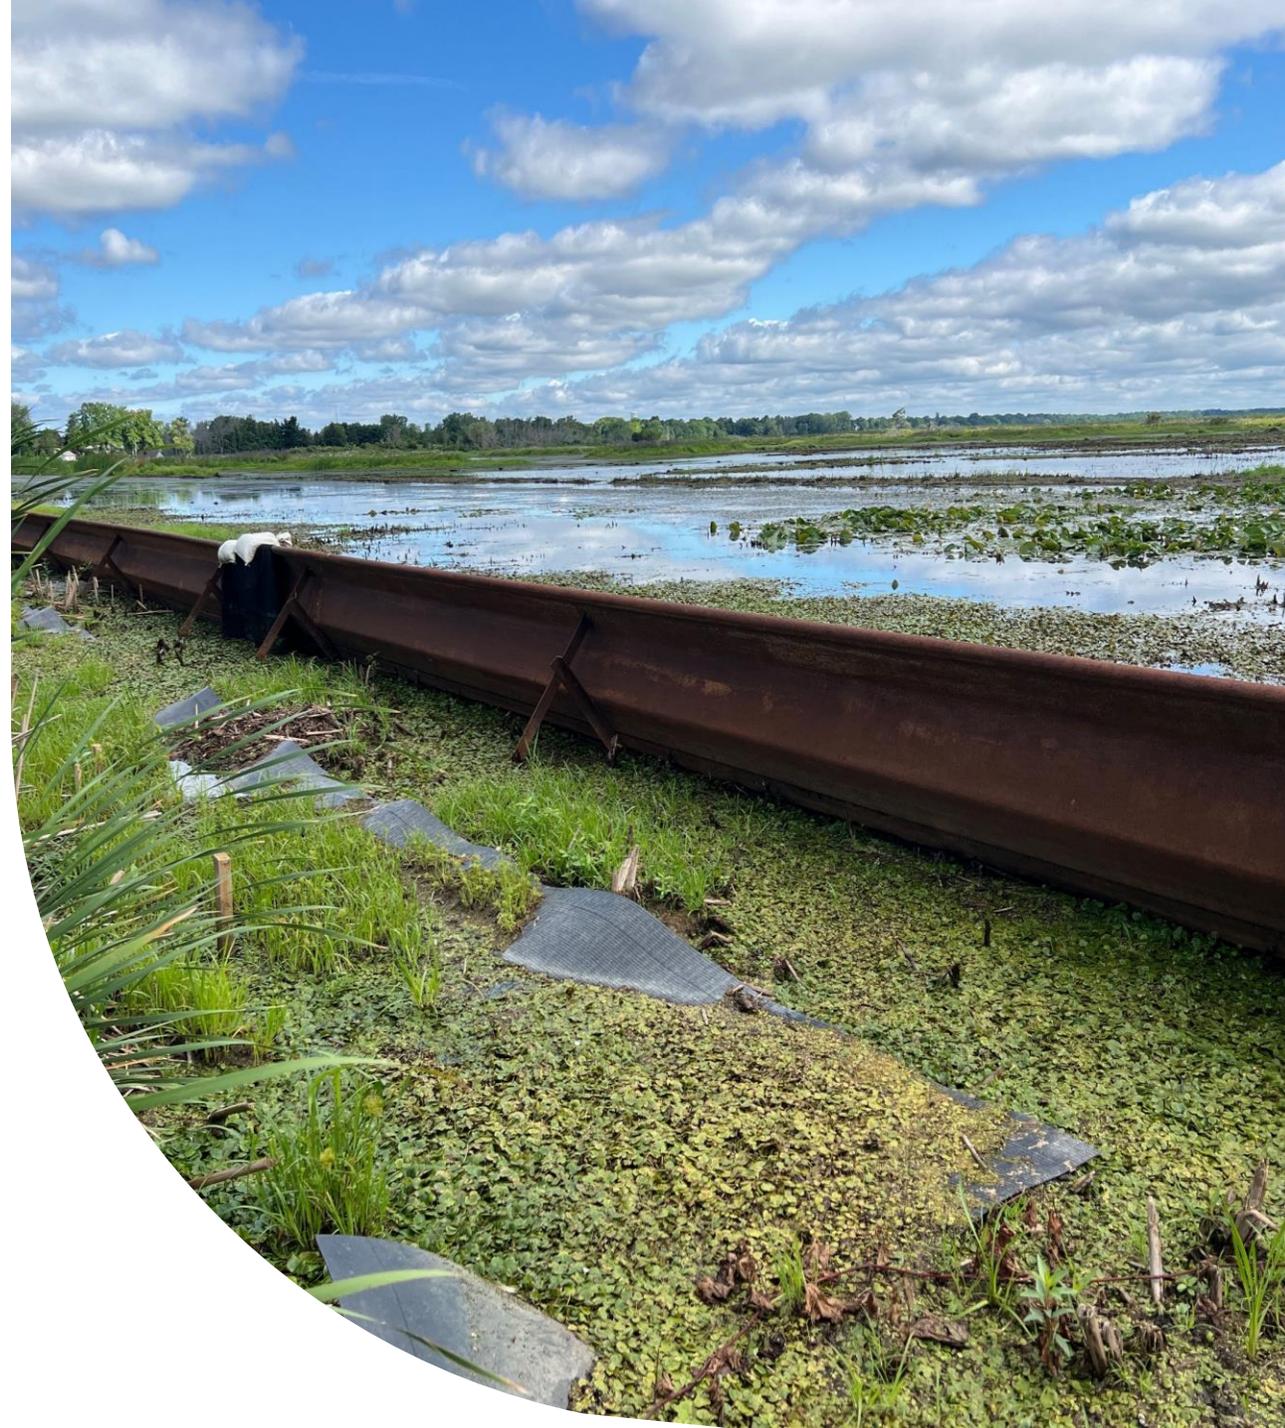
- Use of steel sheet piles to provide wildlife exclusion (and flood protection).
- Multi-barrier approach for bridge work.

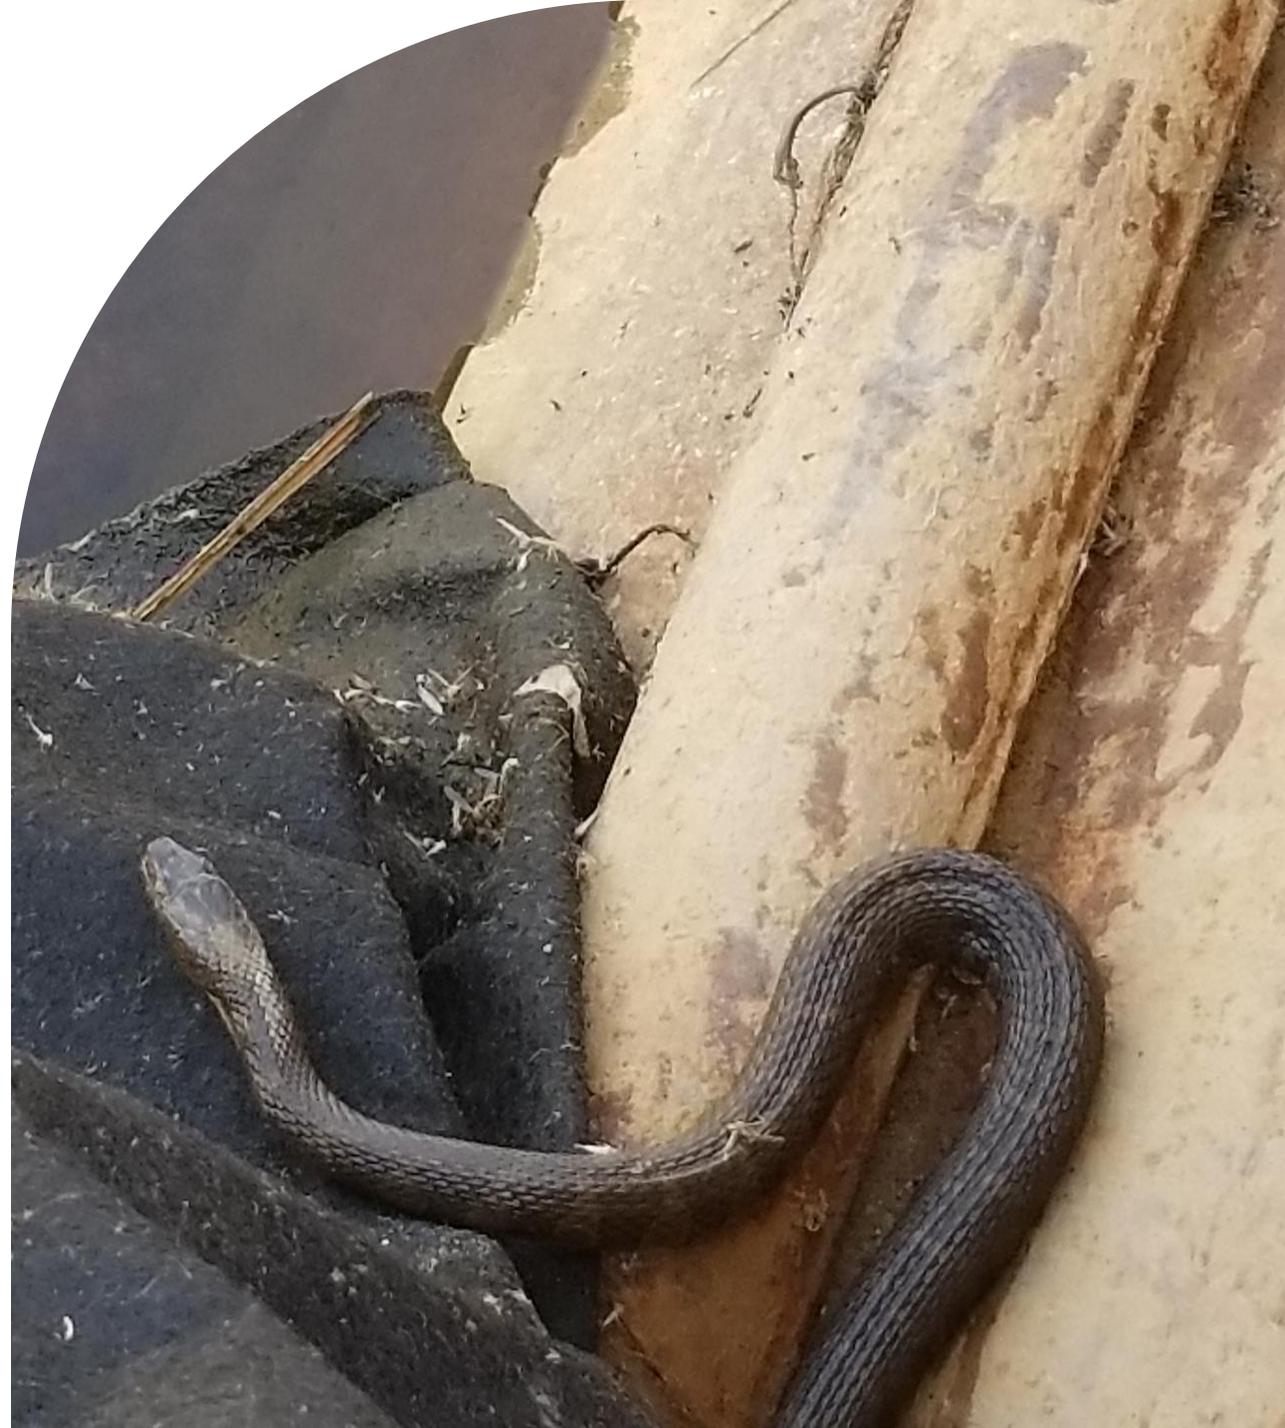
- Private roads and driveways present within the project limits.
 - Permanent gaps in perimeter exclusion measures.
 - Maintained for residents to access their homes/cottages.
 - Noted increase in wildlife activity in these areas.
 - Increased focus of inspections and monitoring on these areas.
 - Communication with residents.

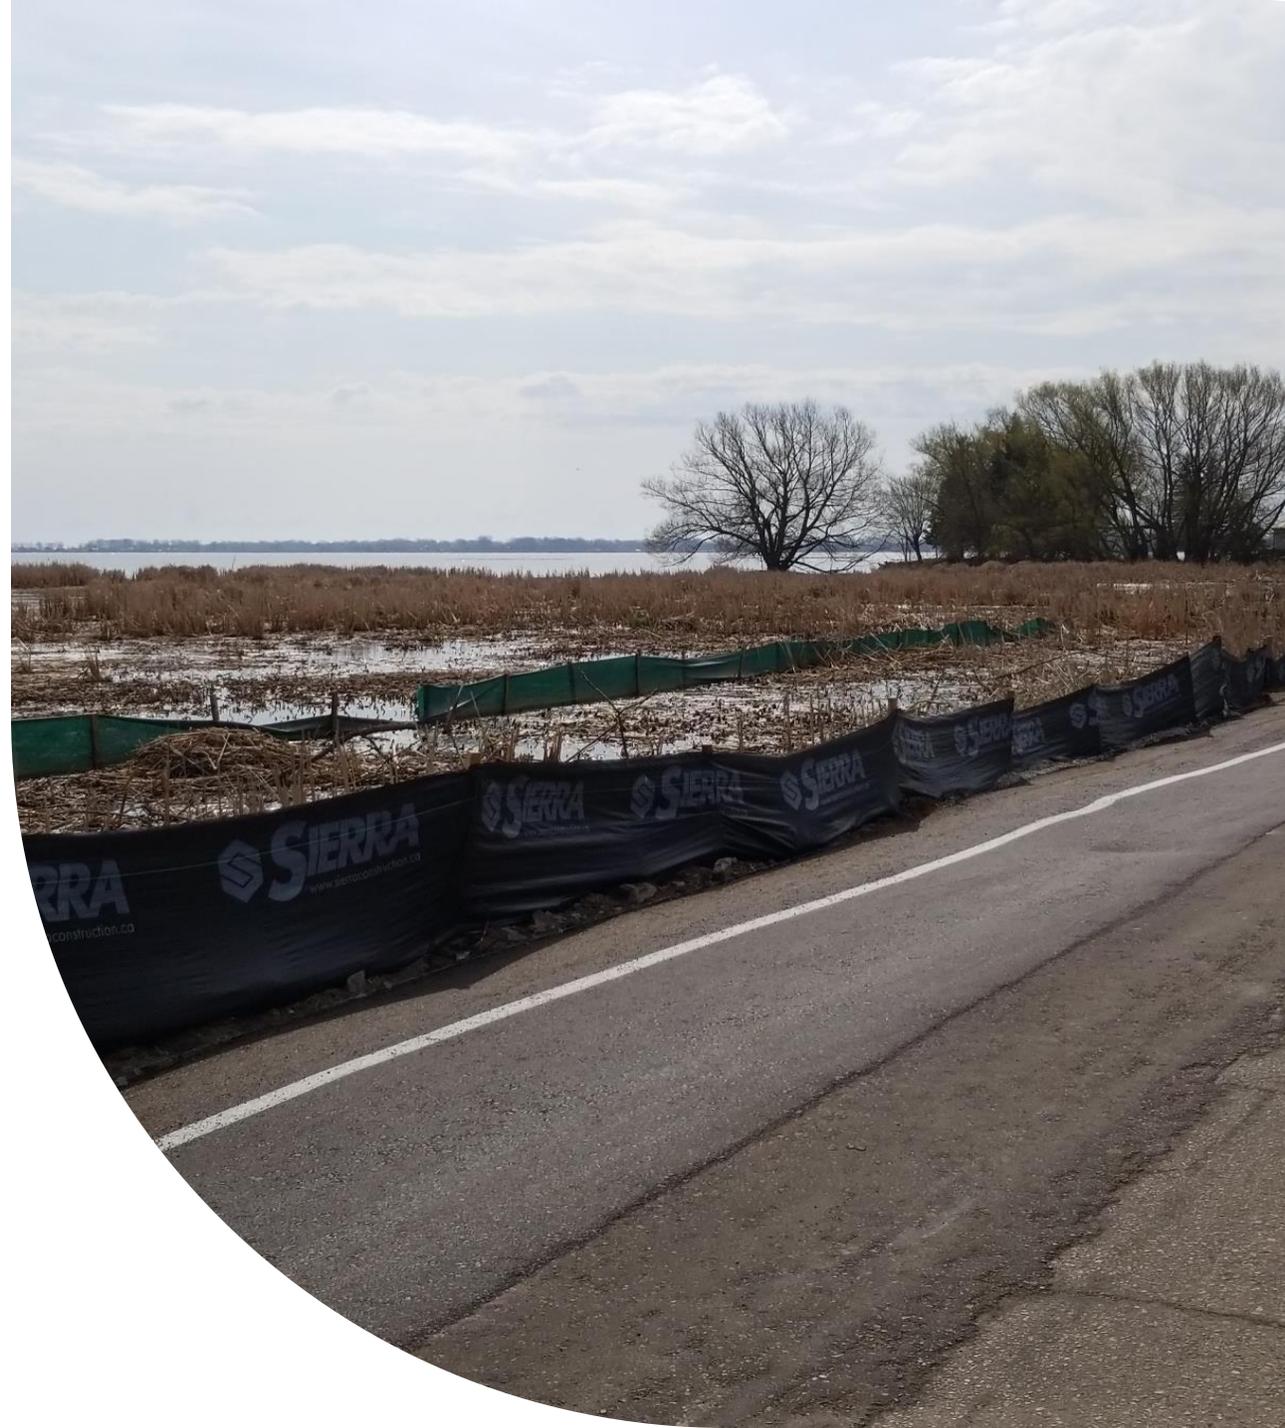
- Silt fence barrier as wildlife exclusion and siltation control.
 - Road base was variable in composition and narrow shoulders.
 - Persistent wind and degradation.
 - Burrowing muskrats.
 - Increased monitoring, site specific adjustments.

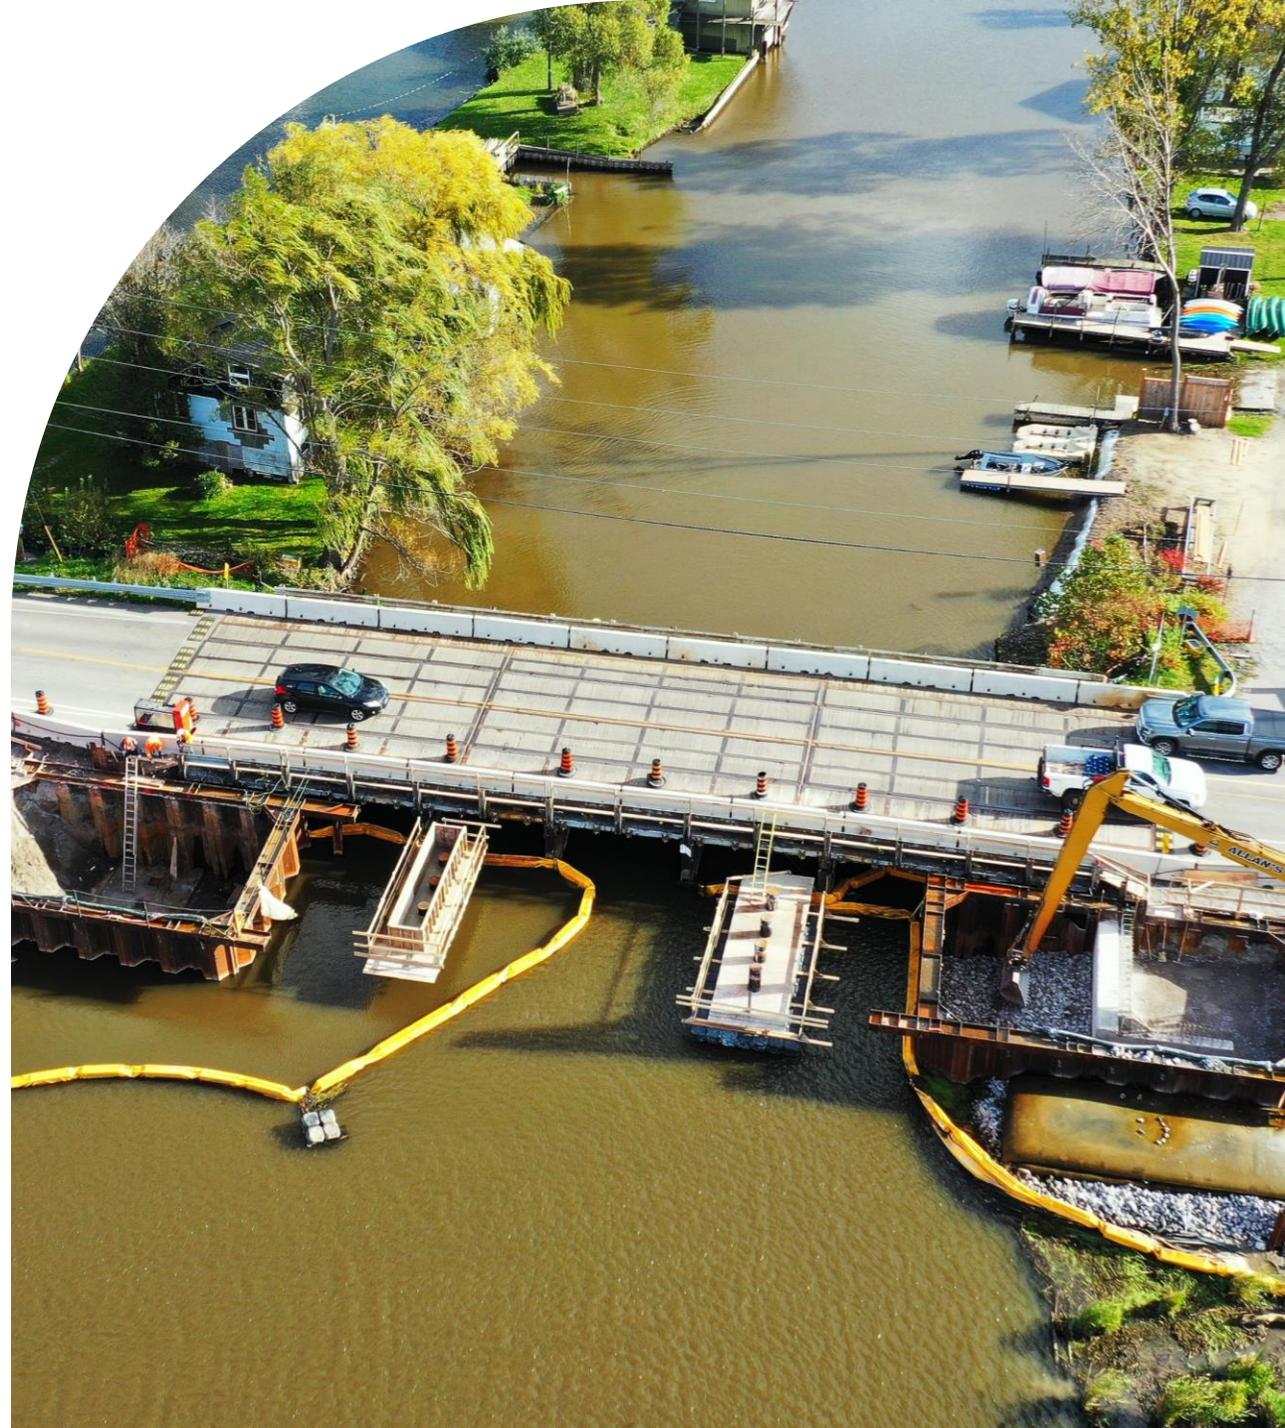
- Reversing flows in Big Creek.
- Variable discharge rates in Big Creek.
- Change in water levels.
 - Constant adjustments, anchoring and re-deployment of turbidity curtains.
 - Delays in work.

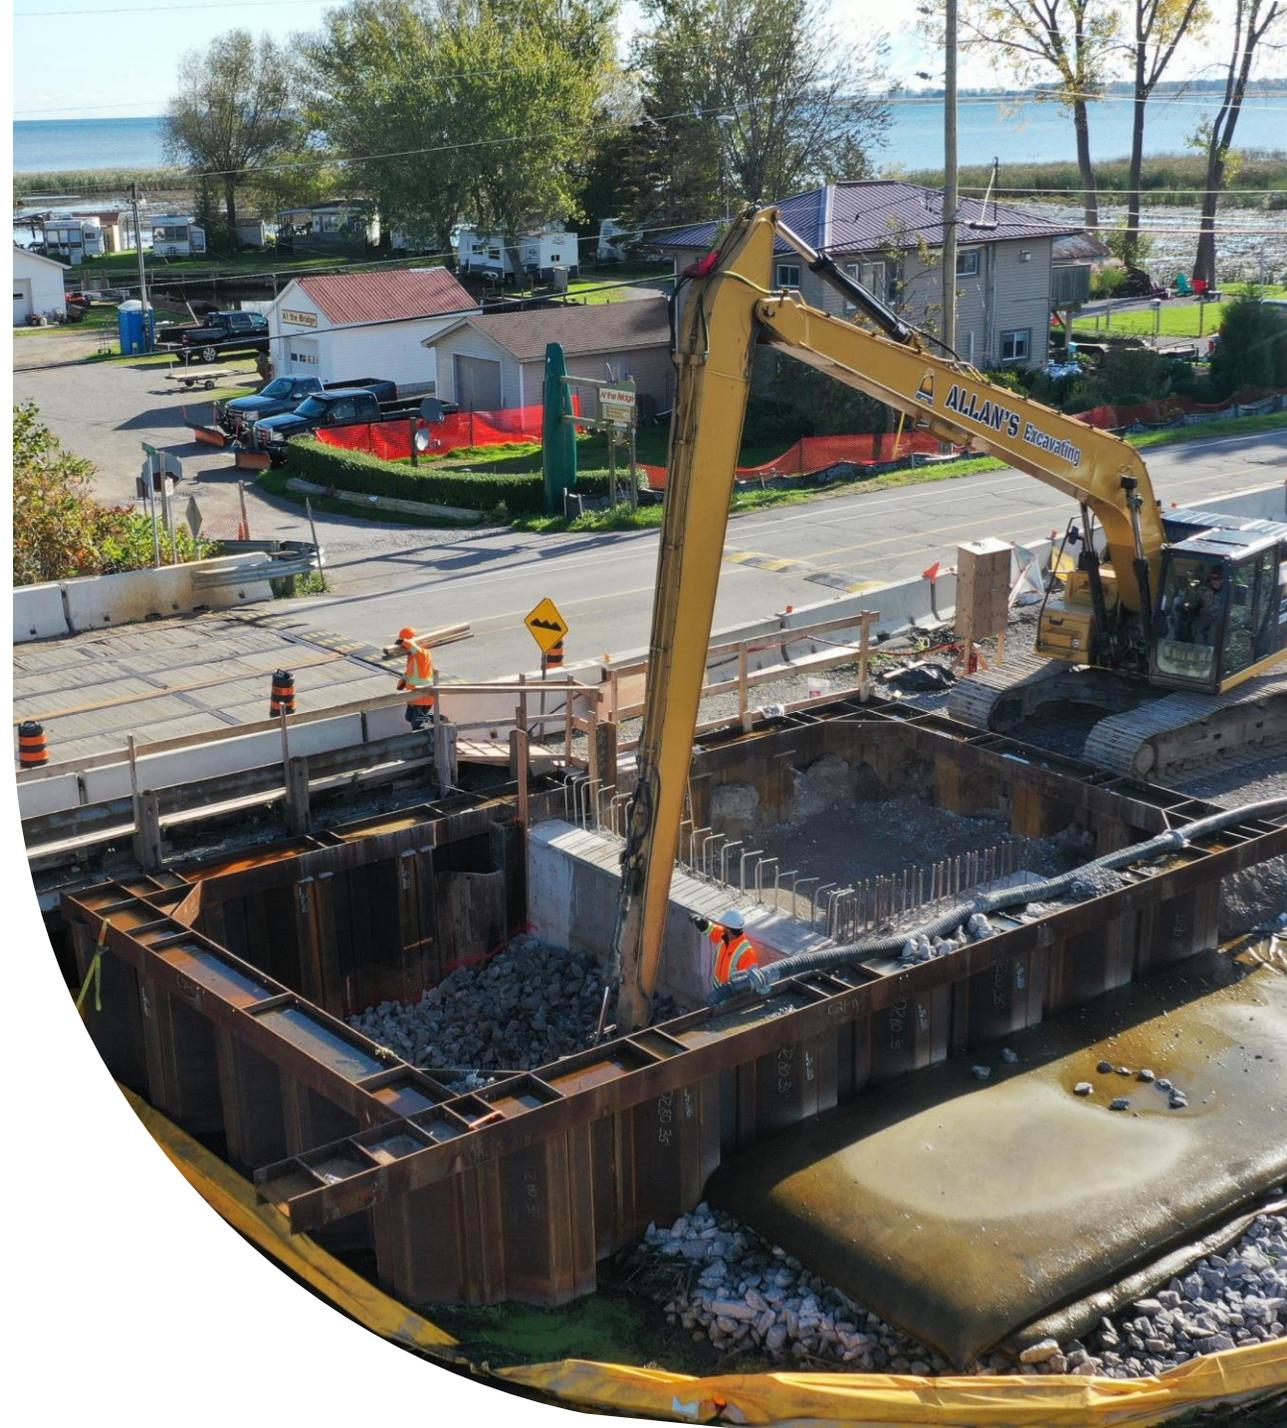
- Narrow causeway and limited areas for staging and temporary works.
 - Excess material managed offsite.
 - Treatment of dewatering discharge.
 - Multi-barrier approach.

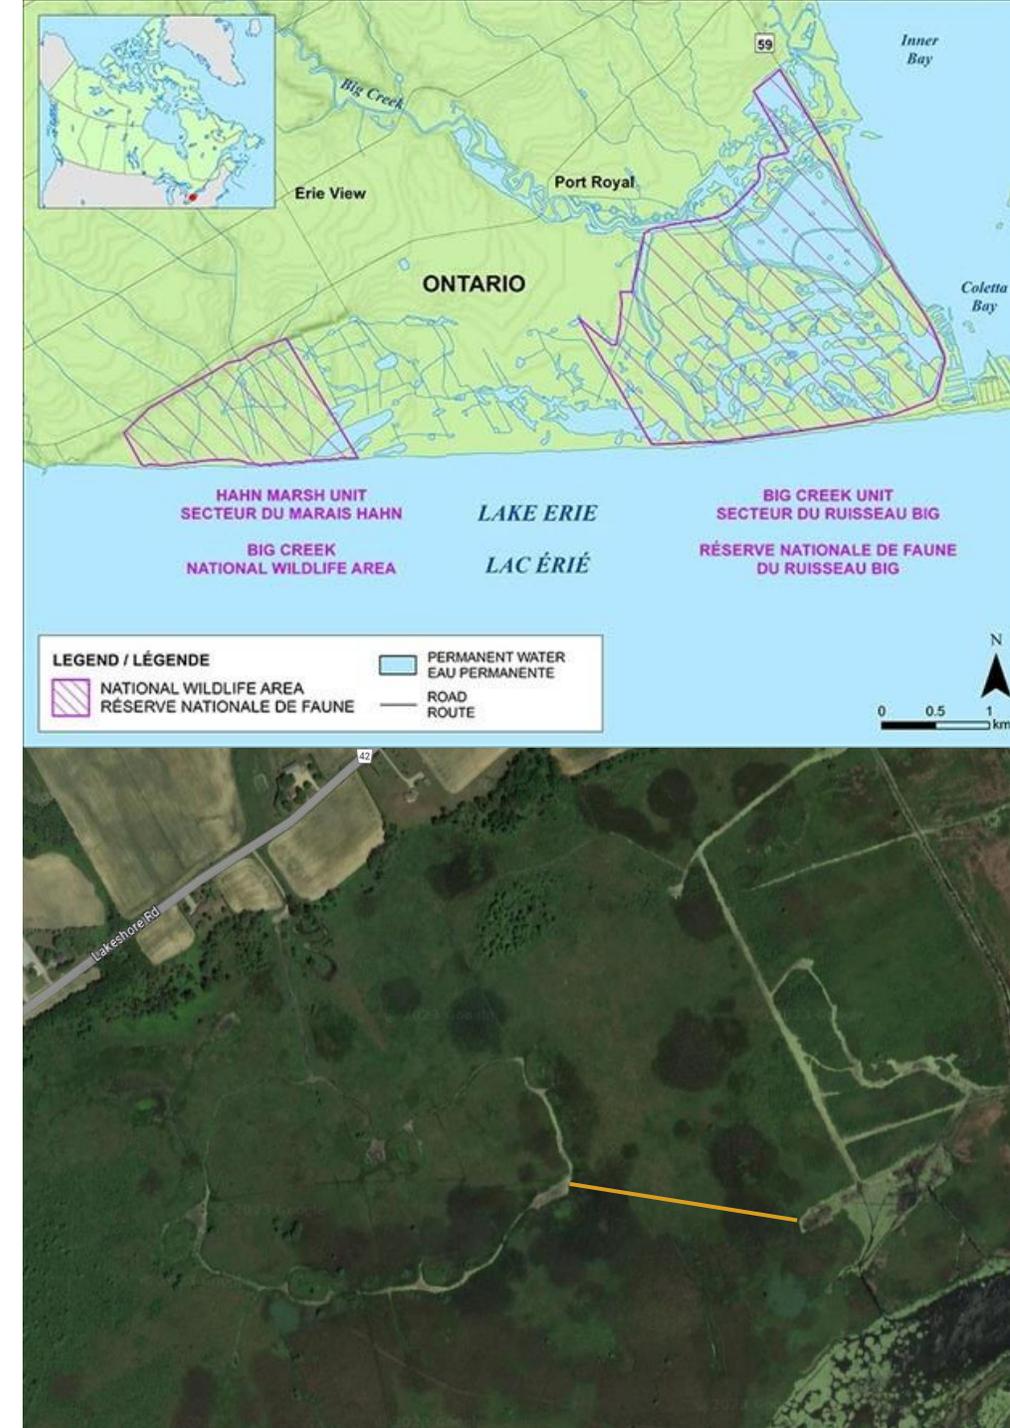
- Compensate for wetland loss at a 4:1 ratio resulting in 2,732 m² of enhancement in the Hahn Marsh Unit in the Big Creek NWA.
- 400 m x 7 m channel connecting two (2) ponds to improve connectivity.

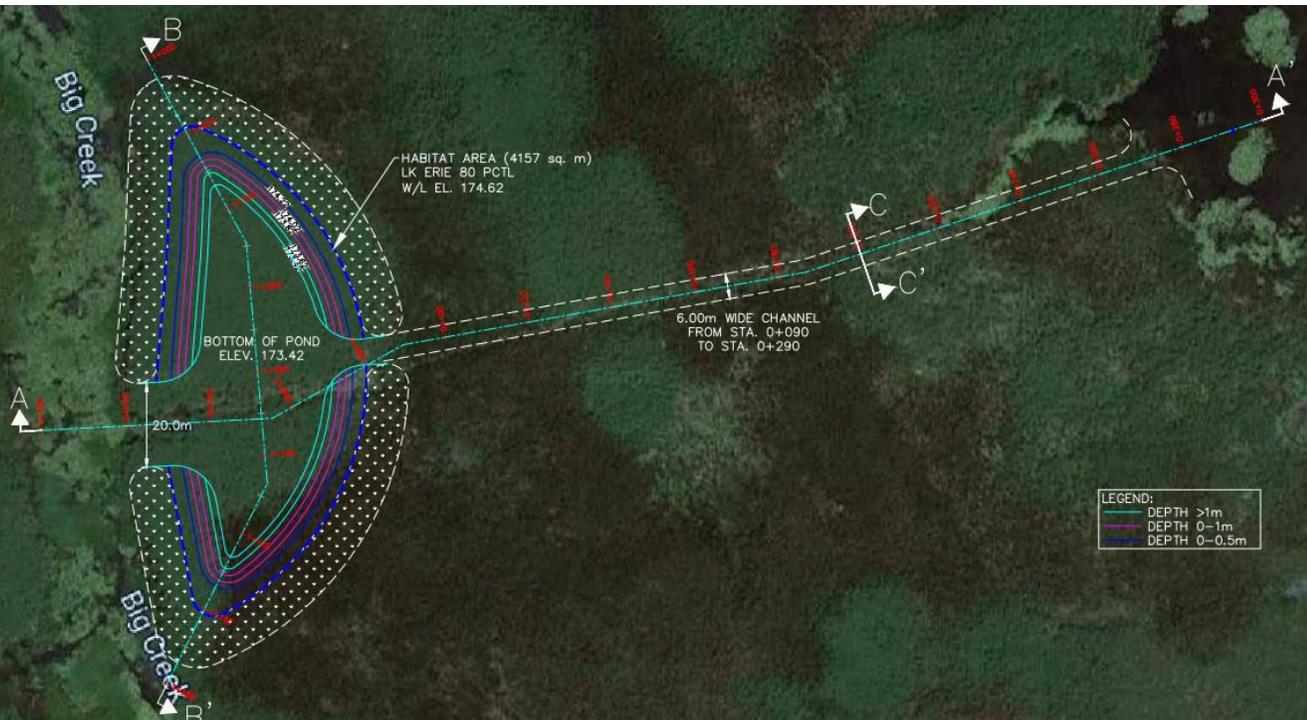
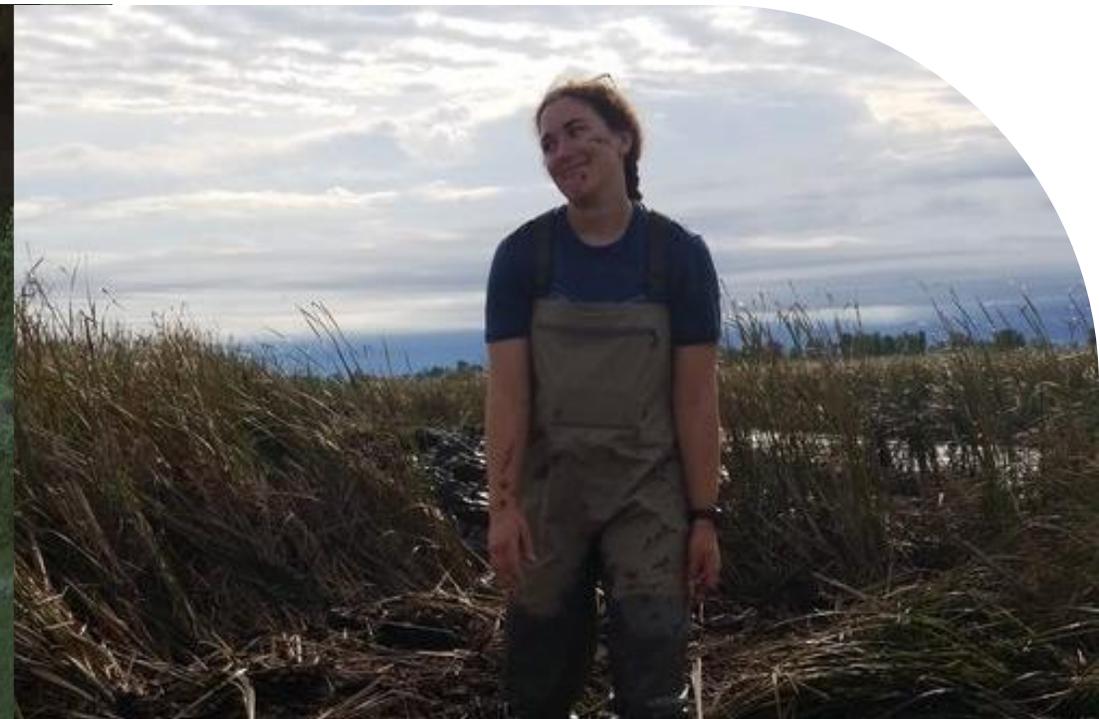
- Compensation of approximately 4,157 m² of wetland habitat at Hastings Marsh.
- 6 m wide channel.

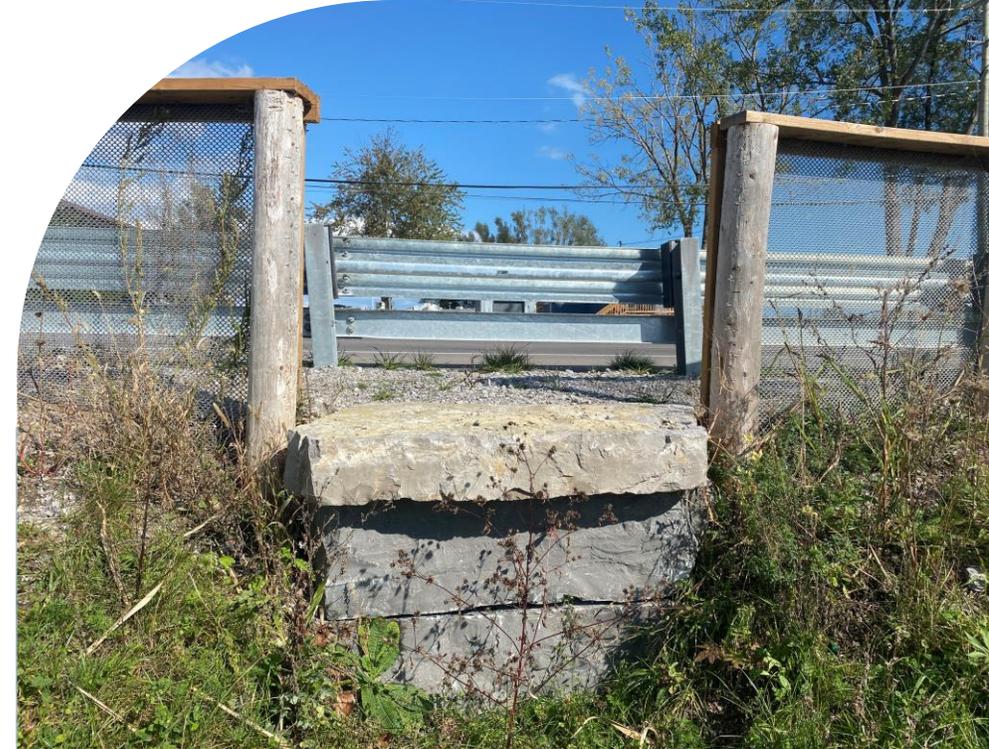
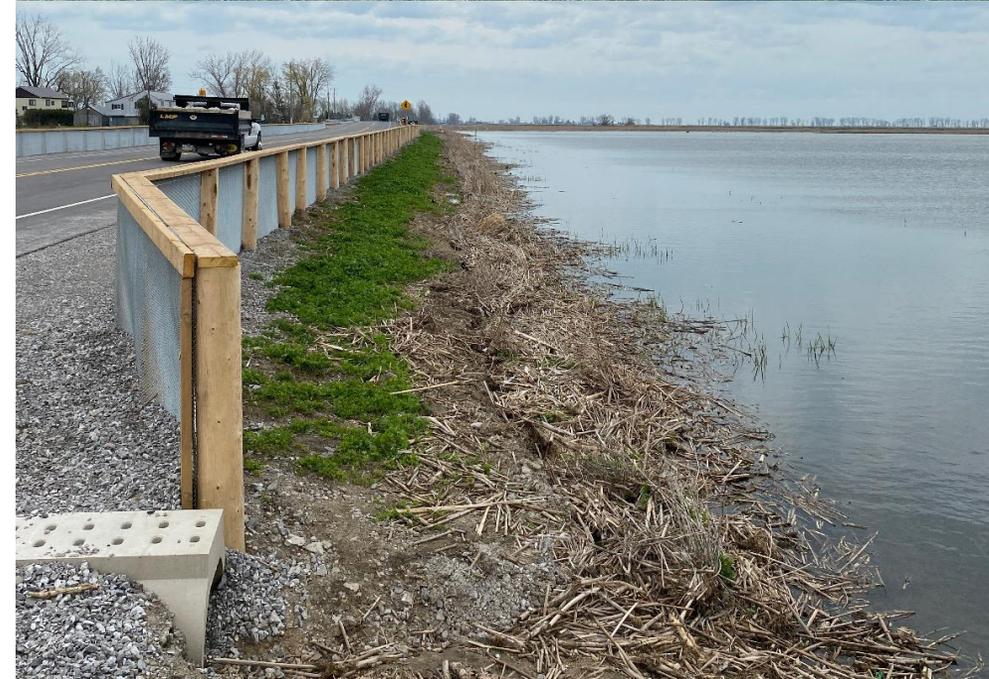
- Constructability and maintenance issues identified by Sierra.
- Re-design completed - input from technical consultant.
- Included escape ramp.
- Effectively implemented to ensure primary objective was obtained - reduce Species at Risk/wildlife road mortality.
