London's Springbank Reservoir Complex

Aaron Rozentals, P.Eng, GDPA

November 12, 2025

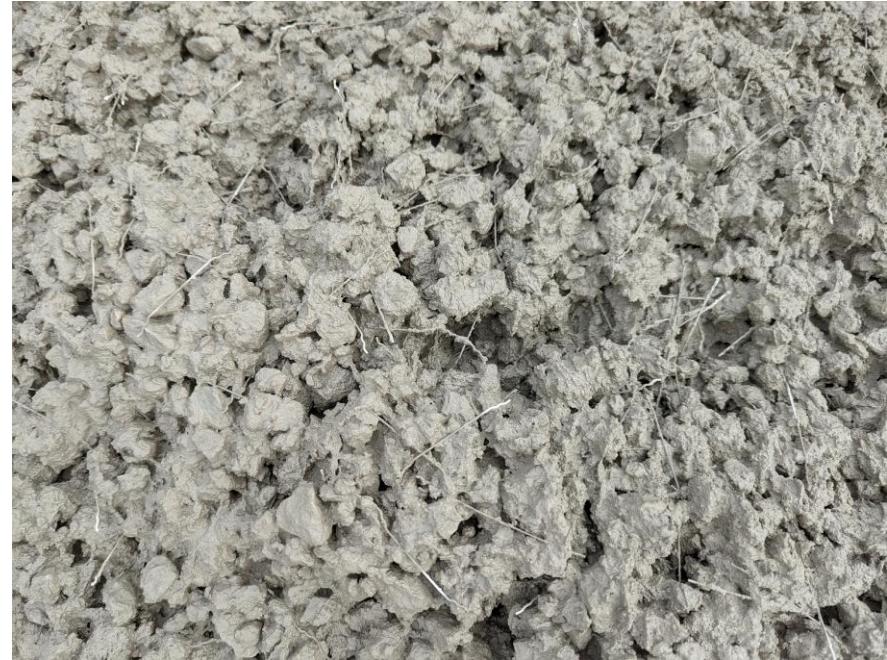
Concrete Topping

- Innovative approach to waterproofing
- Increased cost of approx. \$3M over both reservoirs
- 70-75 year life vs 20-25 year for HDPE
- Net lifecycle savings of \$6M

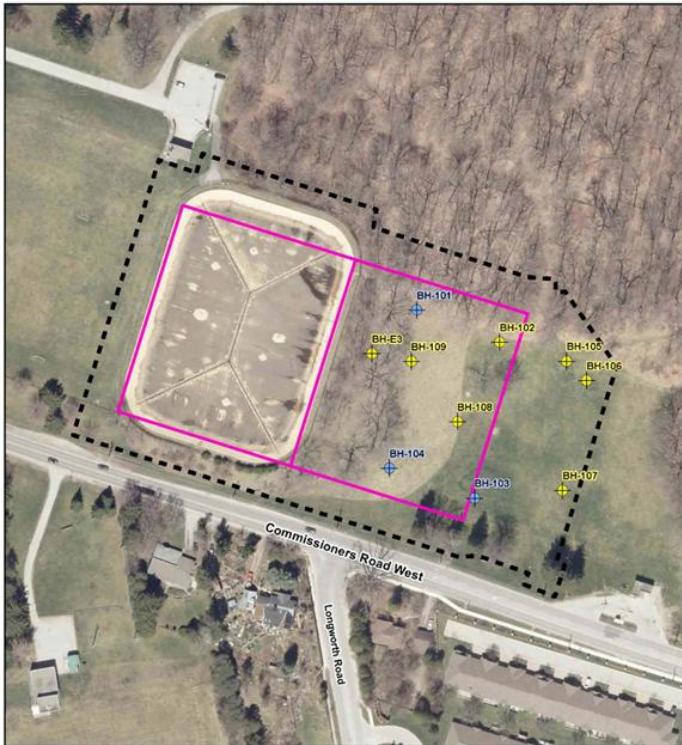
Springbank #2 Reconstruction + Expansion

- Construction from Spring 2024 to late 2026
- 88 ML of floating storage
- Approx 15,000 m³ of concrete
- \$44M Construction
- \$5.3M Consulting
