# A Forensic Investigation: Potential Issues with Recycled Concrete Materials (RCM)

November 18, 2015

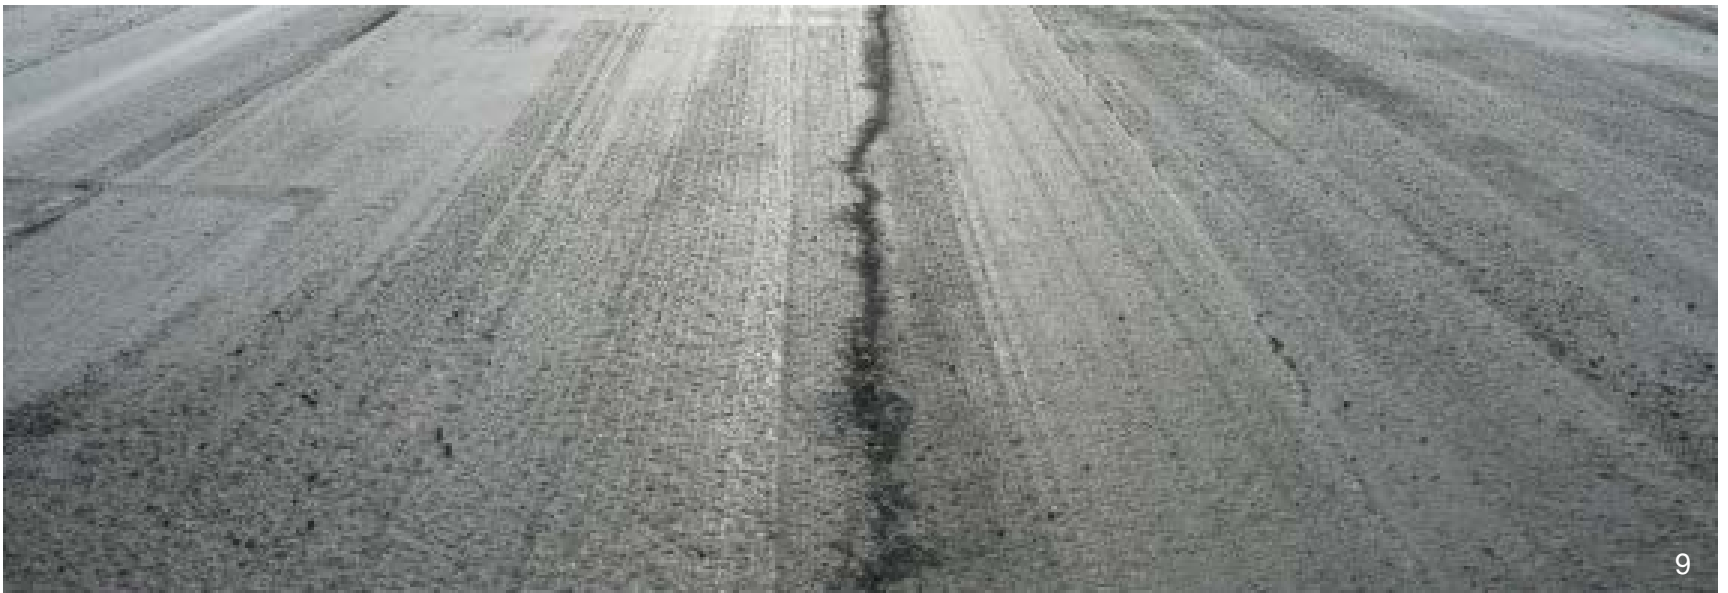
# Possible Causes

- Typical frost heave problem due to winter freeze/thaw?
- Material problem? If so, which material?

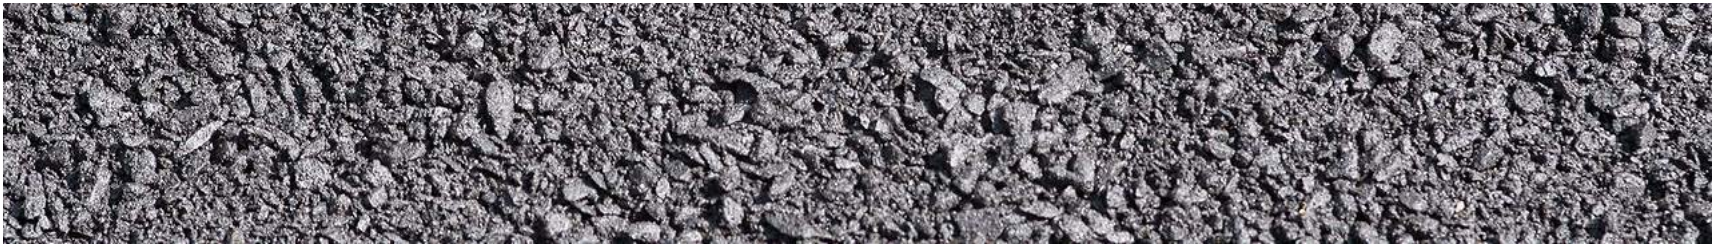
# Possible Causes: Asphalt

- Falling Weight Deflectometer (FWD) test confirmed asphalt is generally structurally adequate
- No issue with material identified

Conclusion: Asphalt not the cause of the problem

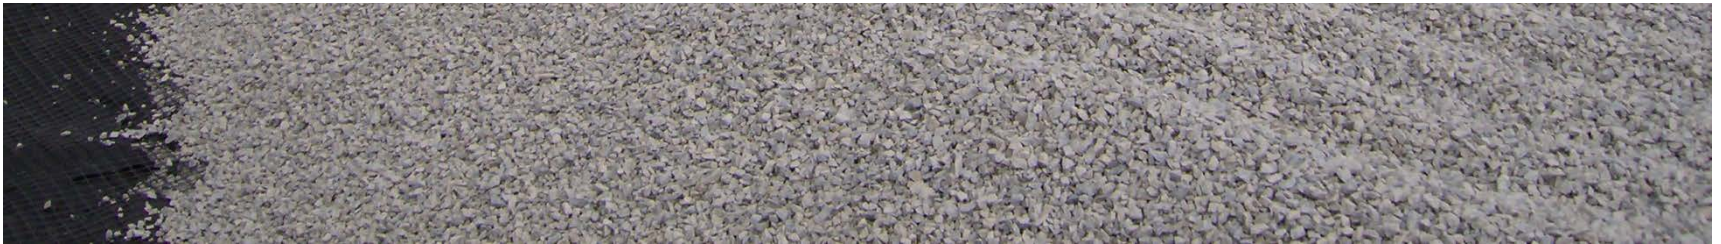
# Possible Causes: Subgrade

- Standard Penetration Test (SPT) confirmed subgrade had good strength
- Grain size/hydrometer test confirmed subgrade material had low to moderate susceptibility to frost heave

Conclusion: Subgrade not the cause of the problem

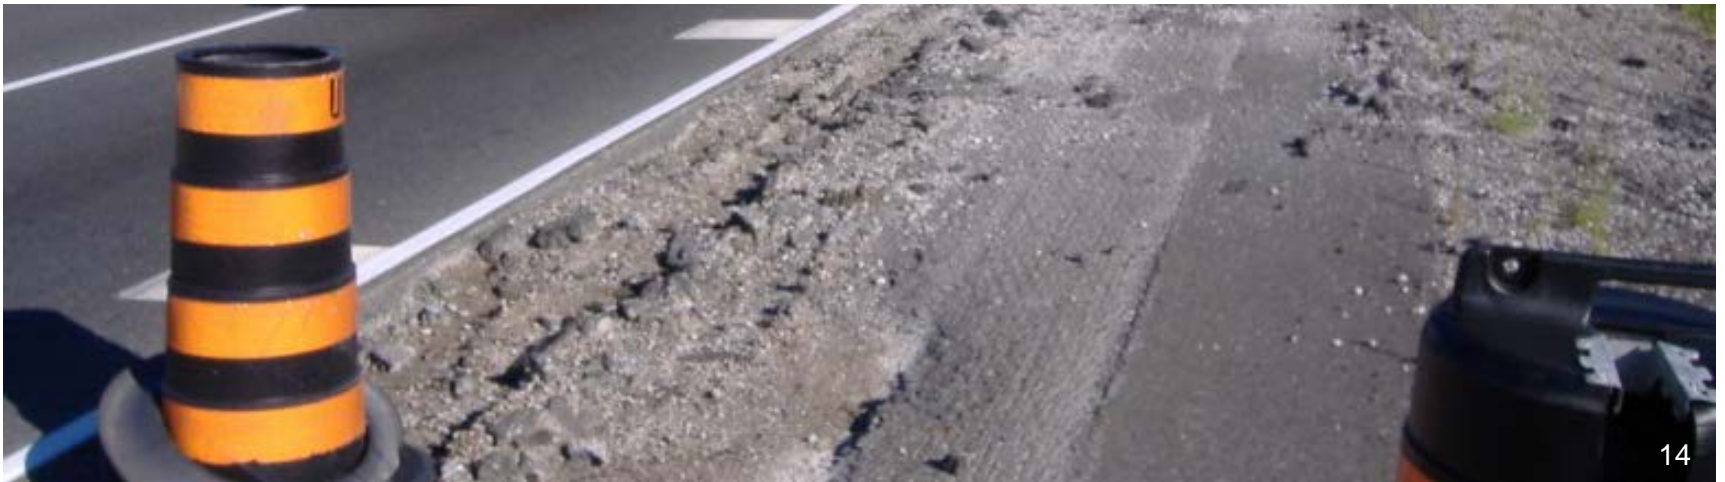
# Conclusion for Drainage as a Possible Cause

- Frost heave?
  - Relatively shallow drainage between the Highway 7 off-ramp to just north of Highway 7
  - Does not explain why there is a problem in high fill areas
  - Pavement remains expanded after two winter periods and repair

Not typical for frost heave situations

- Poor drainage may be a contributing factor to the problem, however it is not the main cause

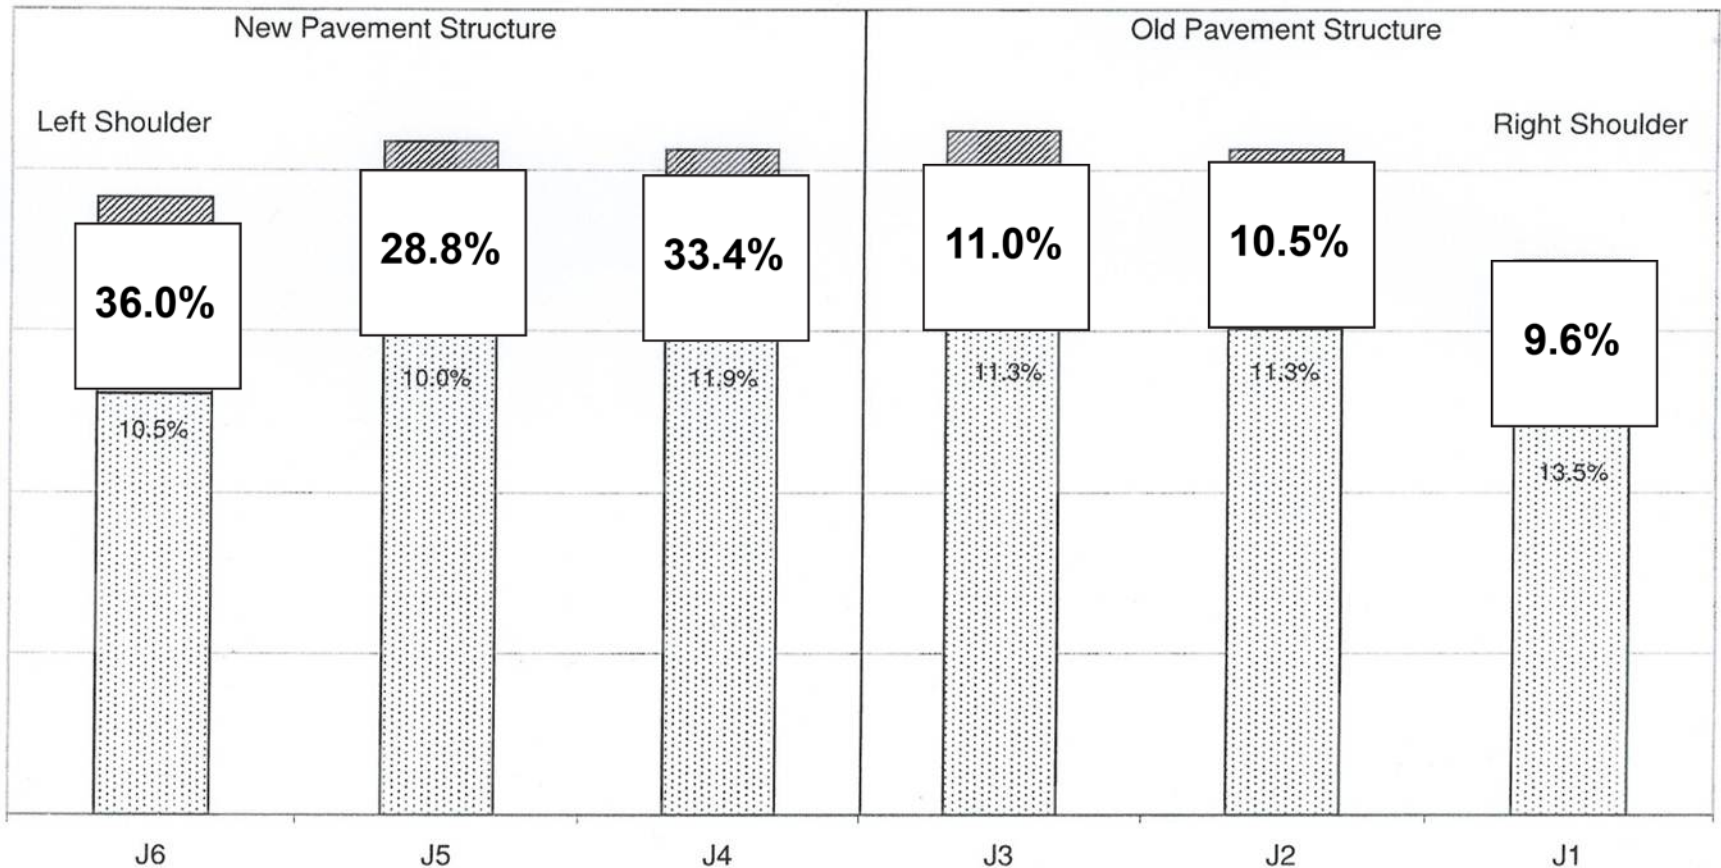
## Moisture Contents

Typical 8 to 11%

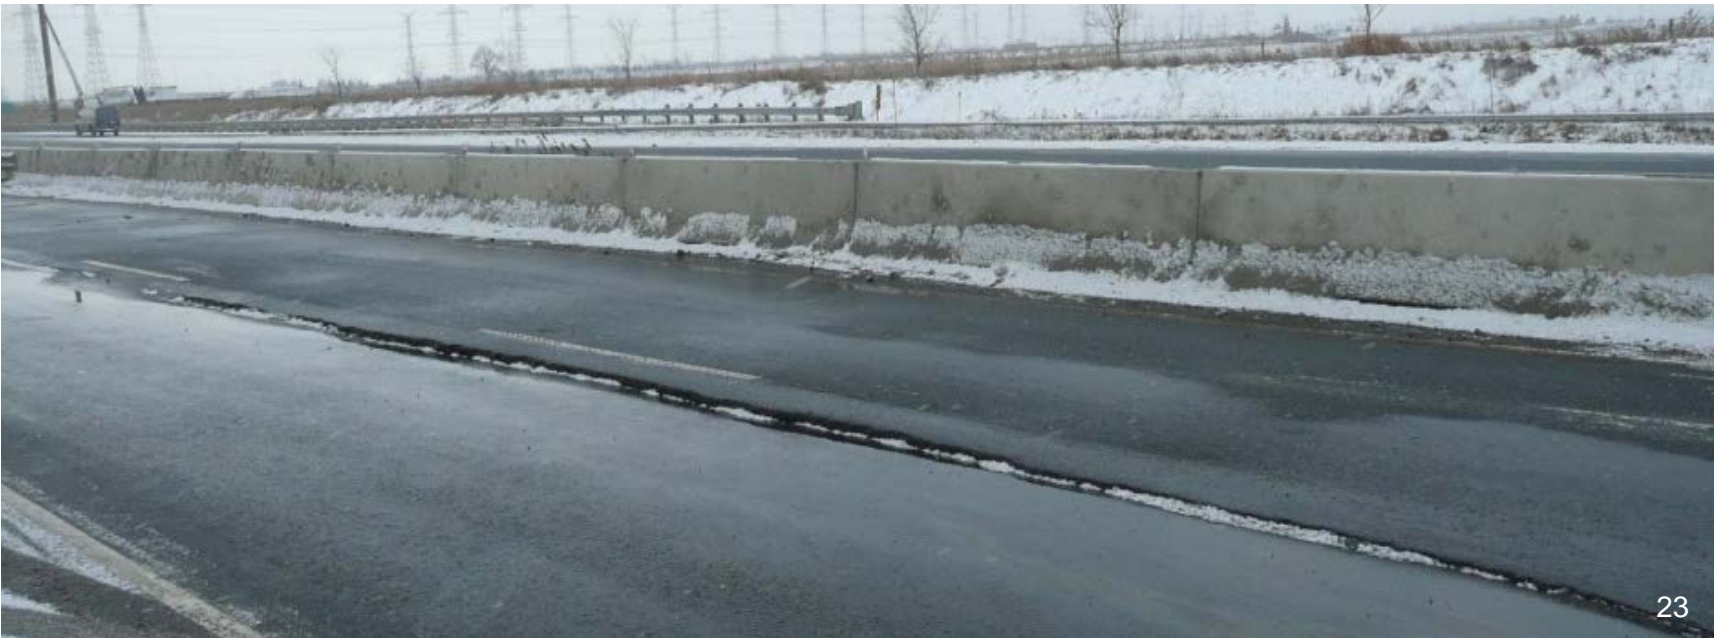
# Conclusion

We theorize that the key factor causing pavement and shoulder problems is the deleterious material in the RCM
